Pre-Demolition Asbestos and Hazardous Materials Survey

Former Sausalito Police Station (29 Caledonia Street) and Sausalito Fire Station #1 (300 Johnson Street), Sausalito, CA.

1 December 2005

Project Number: 05421

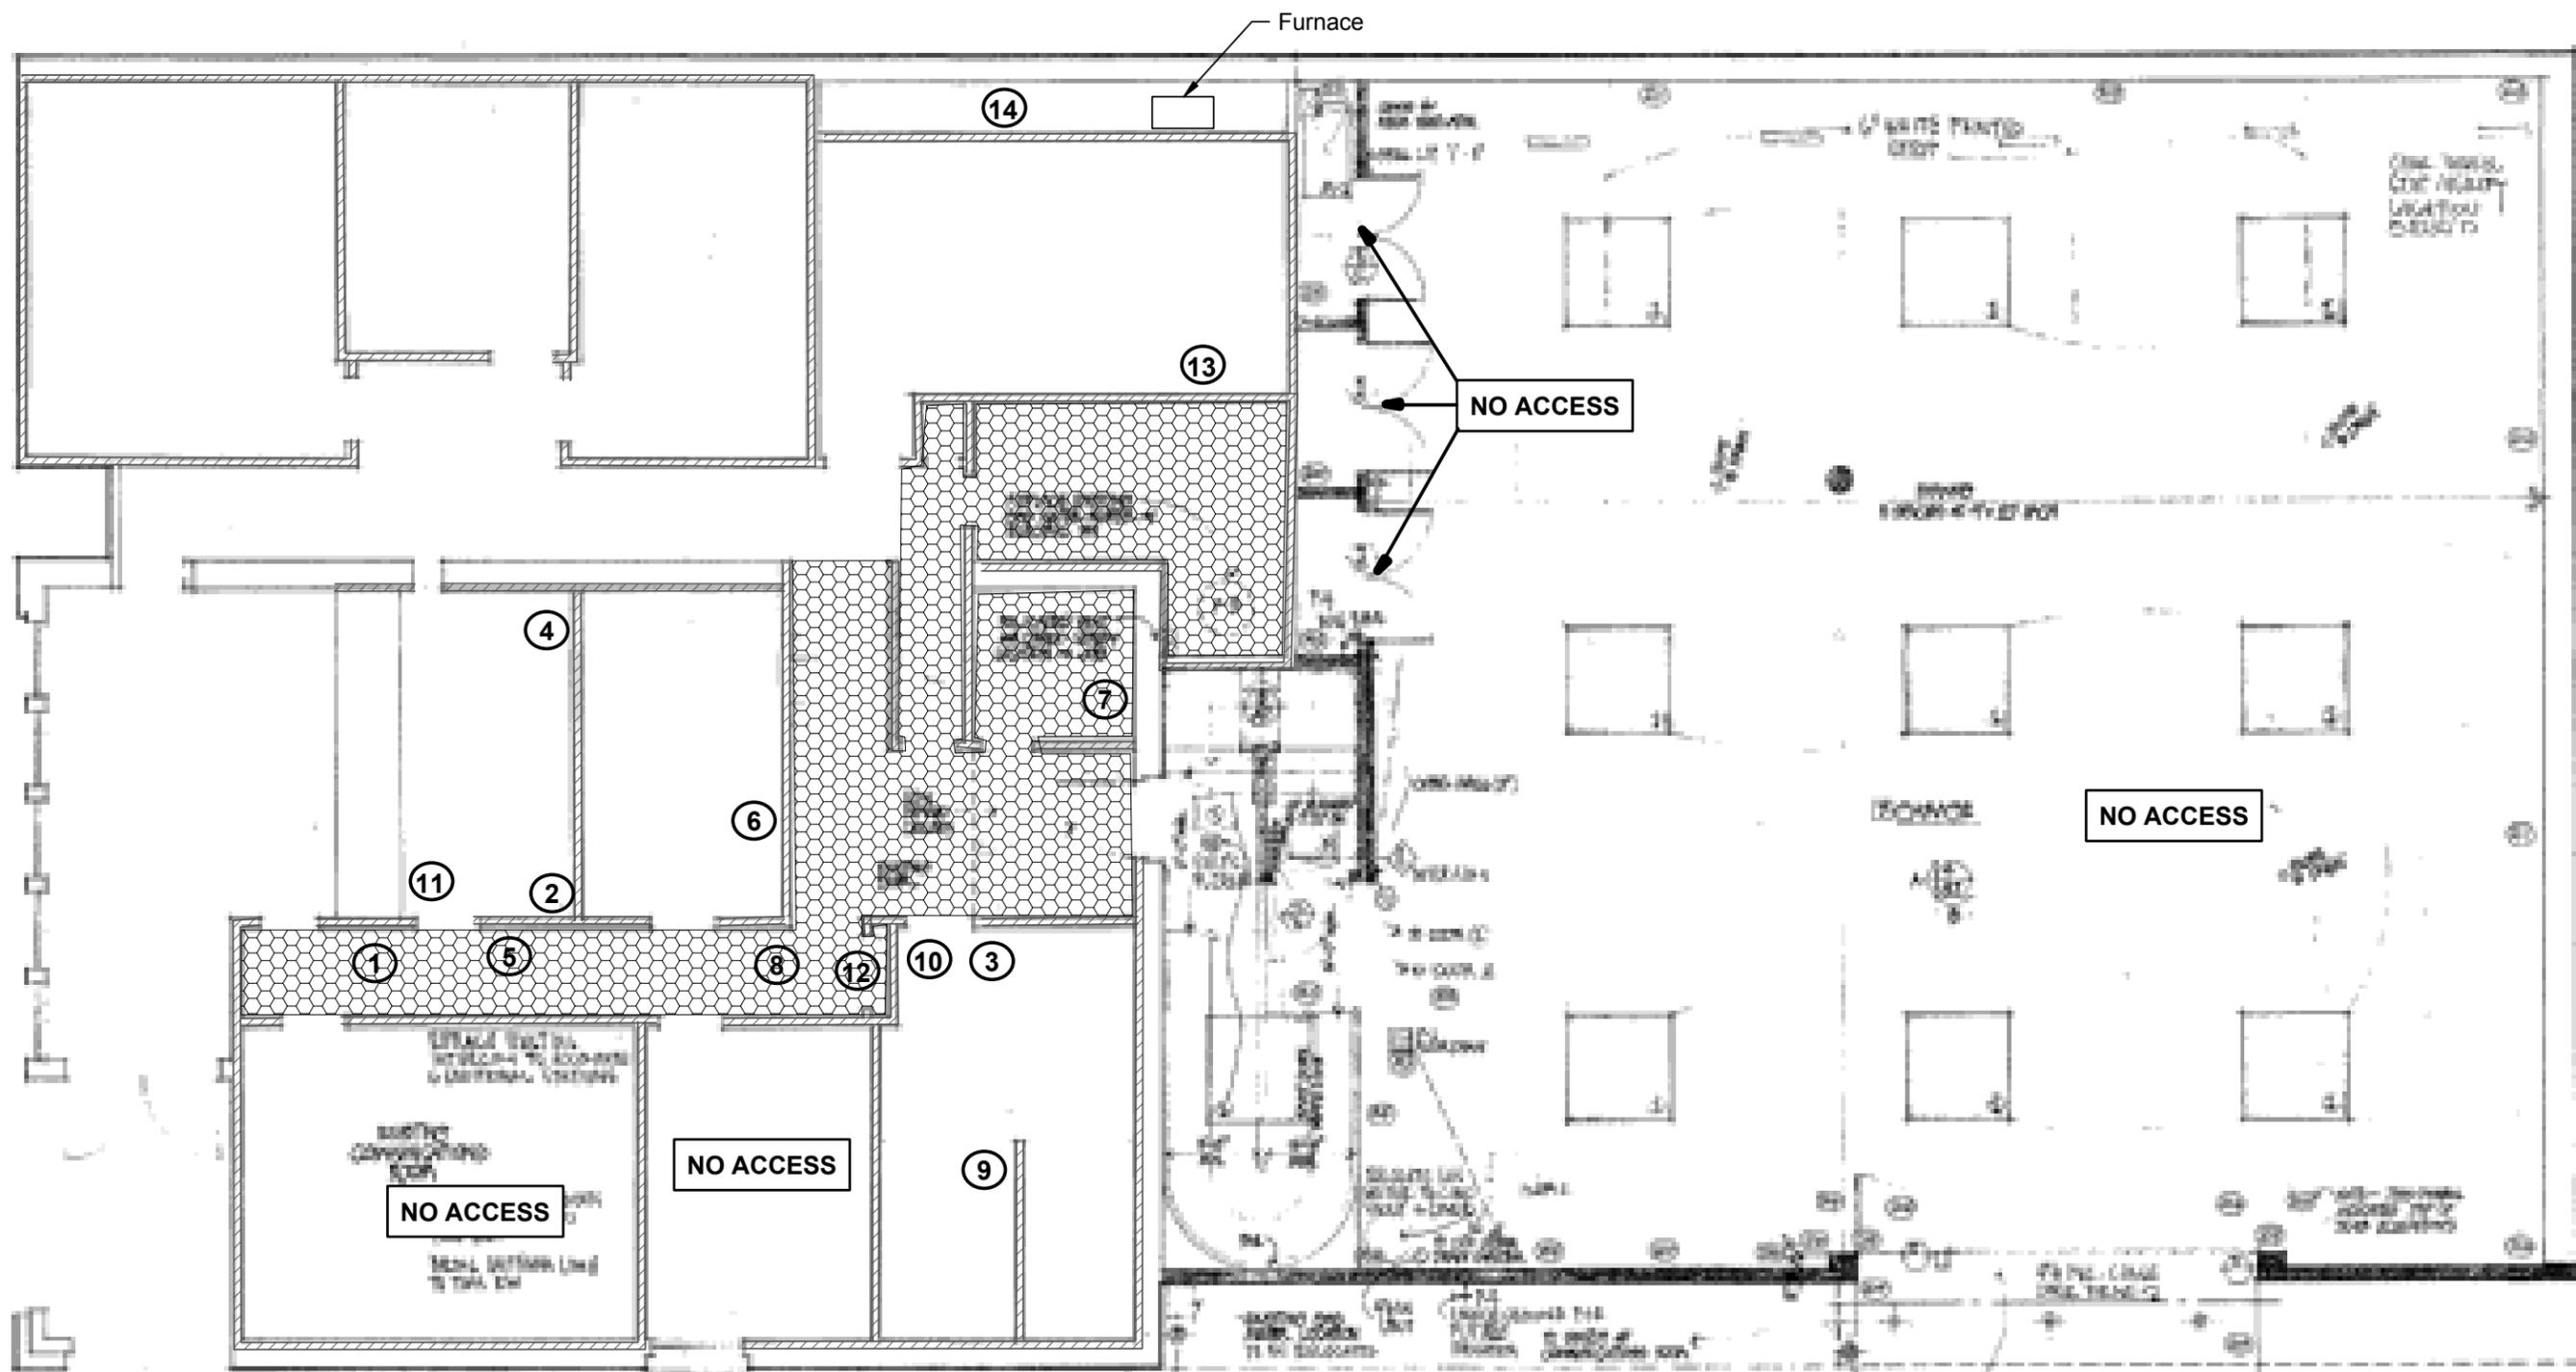
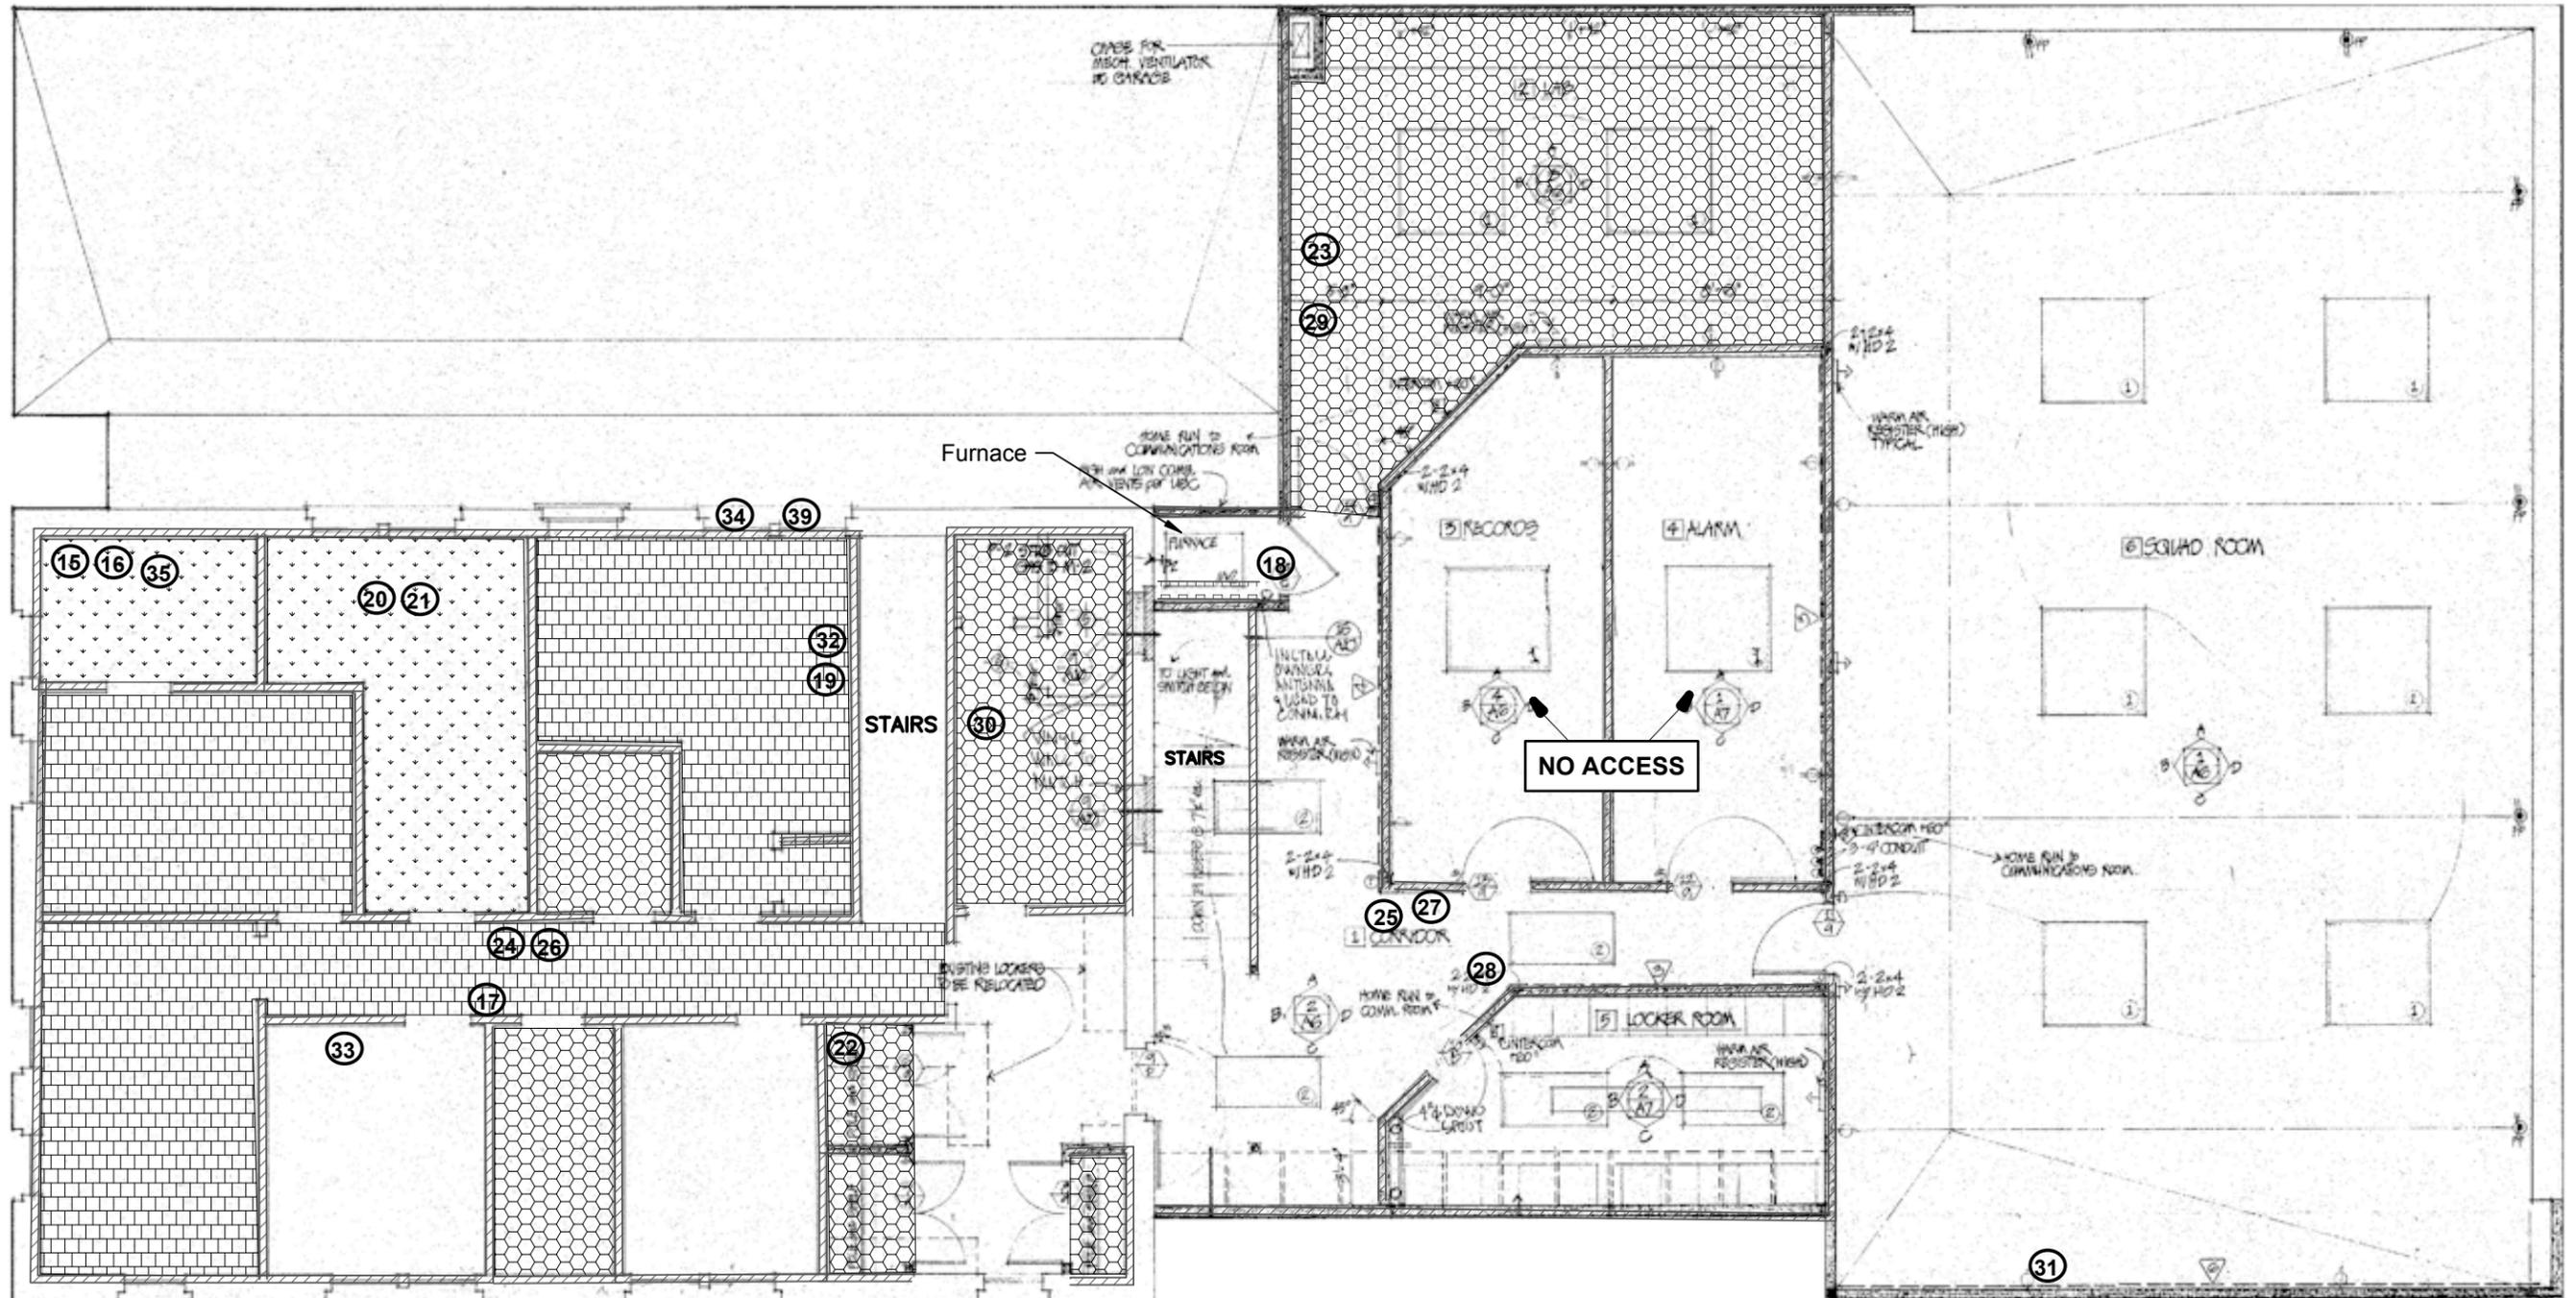
PLATE
1

Asbestos-containing vinyl sheet linoleum

- Asbestos-containing vinyl sheet linoleum
- Asbestos-containing vinyl sheet linoleum backing layer - or linoleum under existing flooring
- Asbestos-containing vinyl floor tile and mastic - exposed and/or under carpeting/flooring
- Asbestos-containing insulation padding on furnace wall
- Sheetrock with asbestos-containing drywall mud/joint compound
- Sample Location

ten-day notification prior to vinyl sheet linoleum abatement. The vinyl sheet linoleum must be removed following BAAQMD and Cal/OSHA guidelines. Friable wastes generated during abatement must be disposed in approved hazardous waste site and transported by licensed hazardous waste hauler.

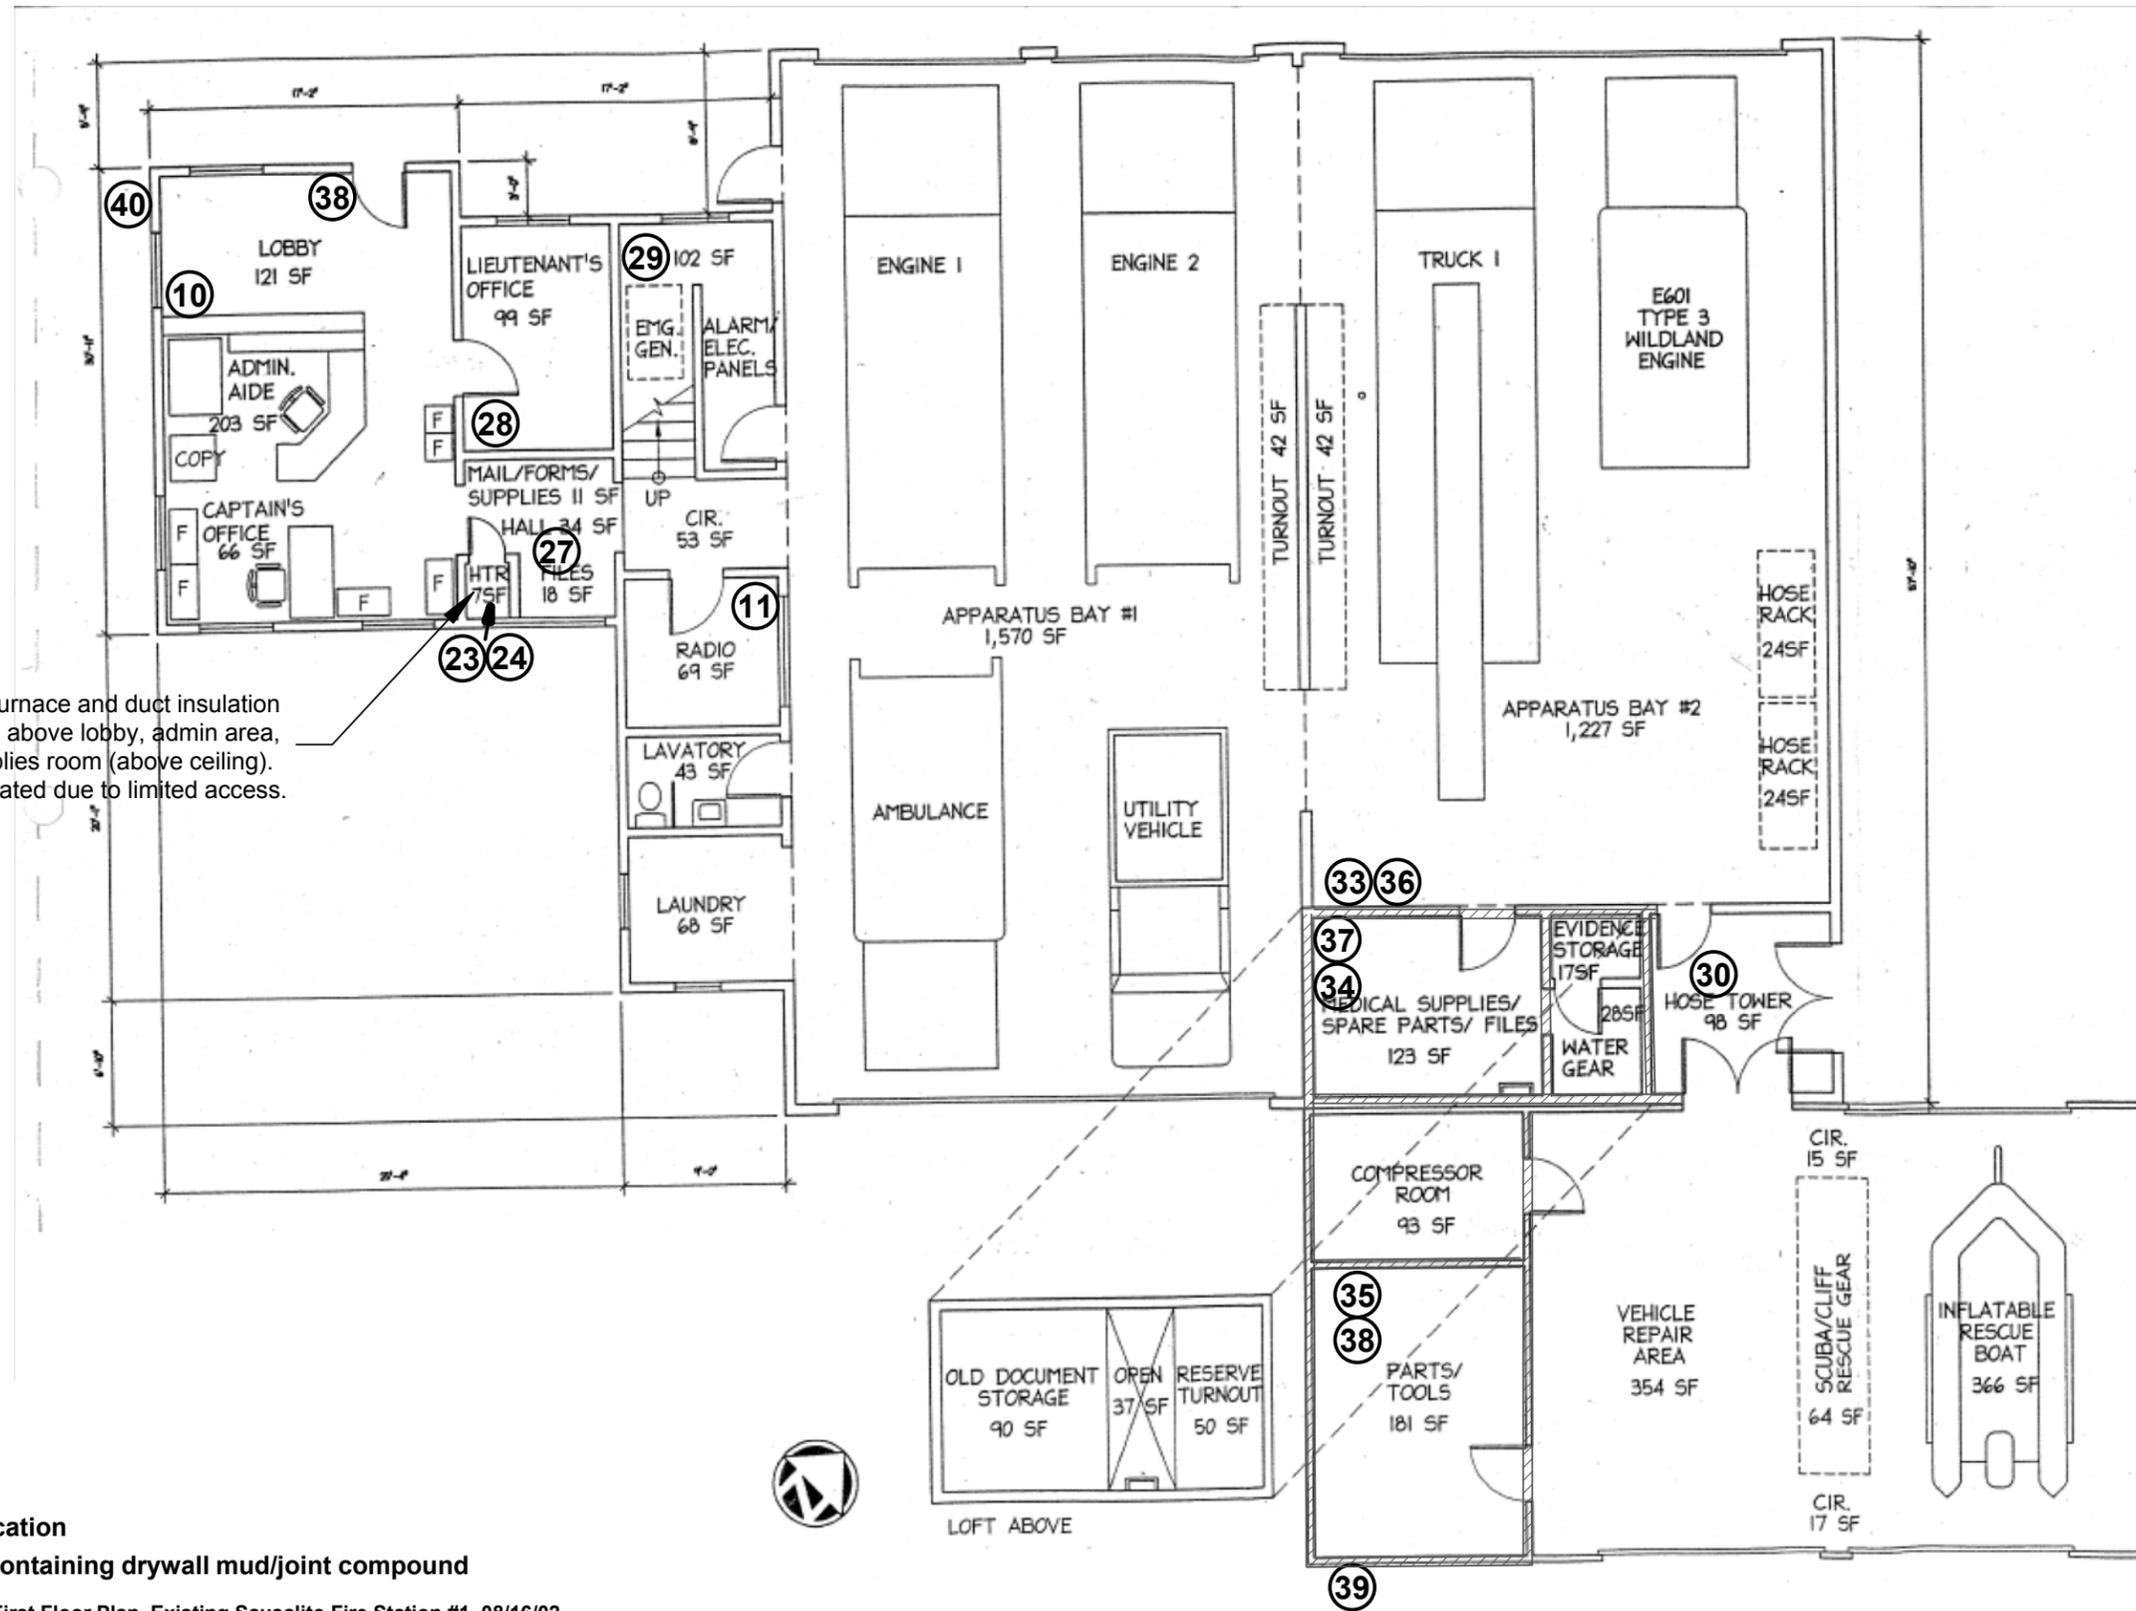
PLATE
3

Asbestos-containing furnace and duct insulation located in heater closet and above lobby, admin area, lieutenant's office and mail/form/supplies room (above ceiling).
Quantity not estimated due to limited access.

- (21) Sample Location
- ▨ Asbestos-containing drywall mud/joint compound

Removal would be required to be completed by a Cal/OSHA registered abatement contractor utilizing glove bag/abatement procedures and/or the entire ducting and insulation can be removed as a unit. Bay Area Air Quality Management District (BAAQMD) and Cal/OSHA would not require a ten-day notification prior to thermal insulation abatement. The HVAC wall insulation pad must be removed following BAAQMD and Cal/OSHA guidelines. Friable wastes generated during abatement must be disposed in approved hazardous waste site and transported by licensed hazardous waste hauler.

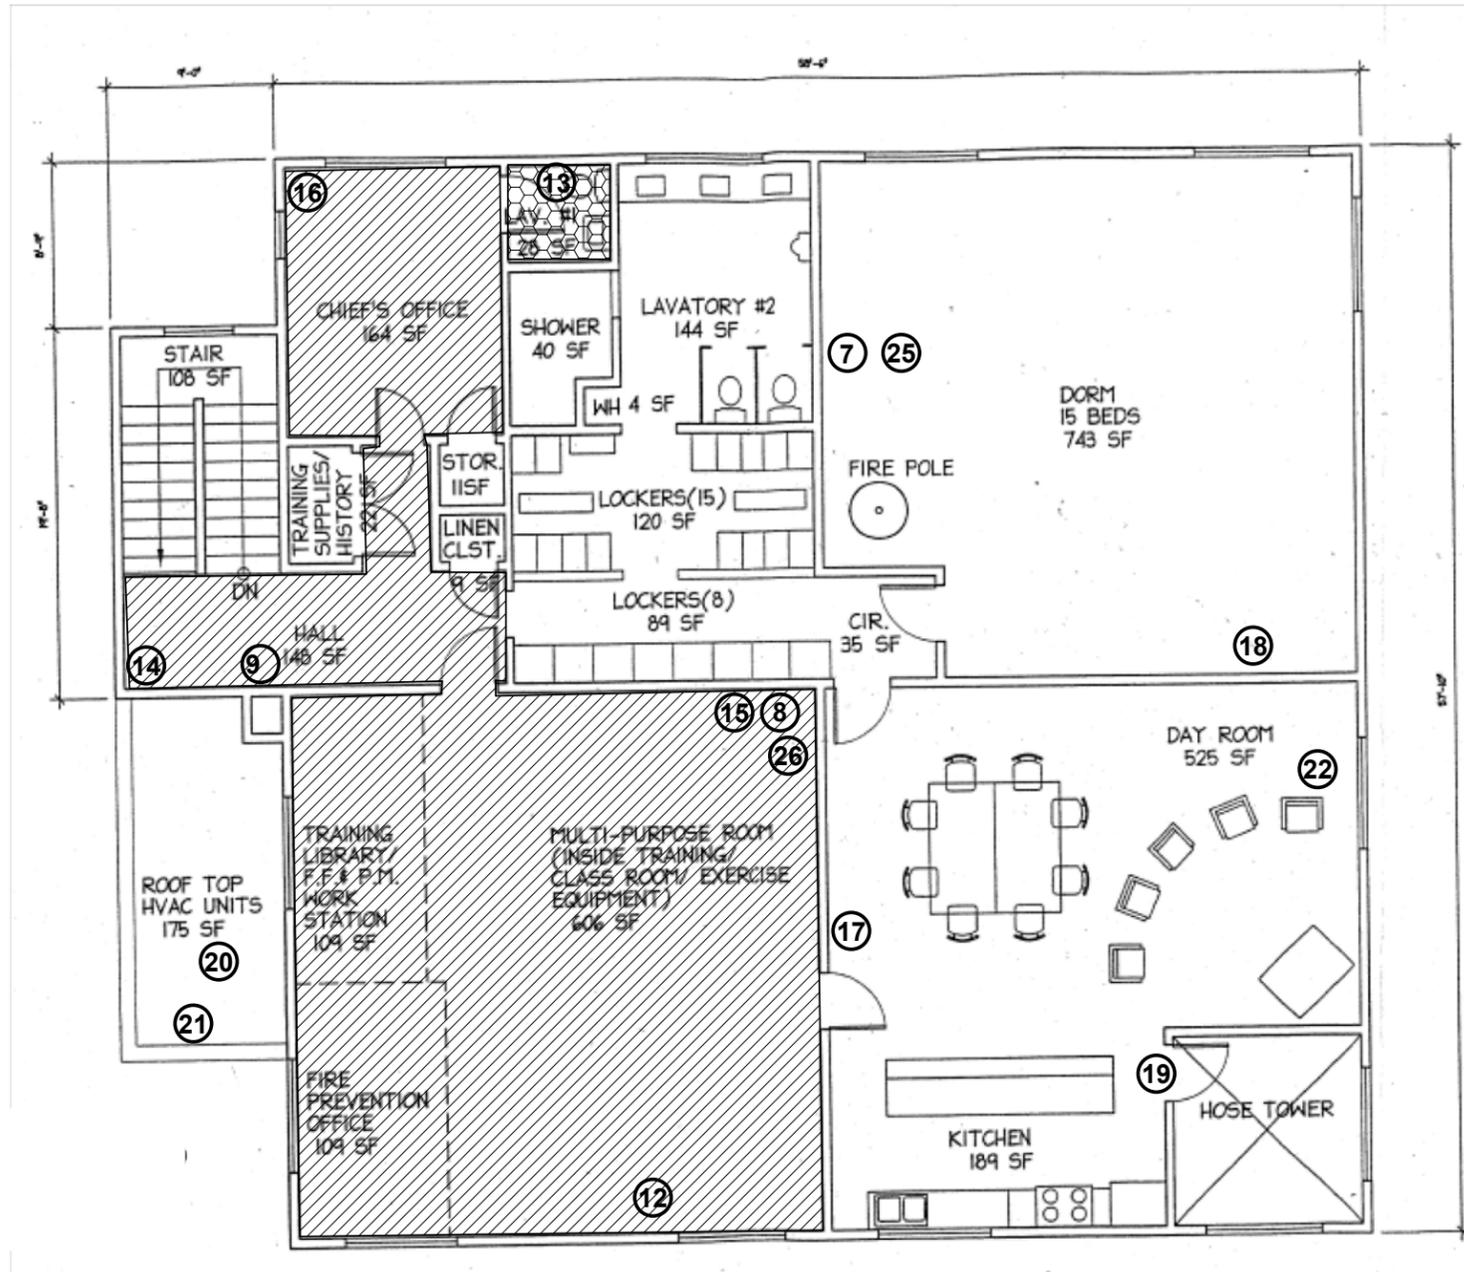
Asbestos-containing register boots insulation located in dorm (2), Day Room (2), Multi-purpose Room (2), and Chief's Office (1) areas - duct source unknown. Asbestos-containing duct insulation may exist in space between the first and second floors. Fiberglass and non-insulated ducting was observed in attic crawl space above locker room ceiling.
