Appendix A

300 Locust St.
Sausalito
Marin County, CA

Appendix A Miller Pacific Engineering Group
Site Plan, Boring Logs, and Settlement Table

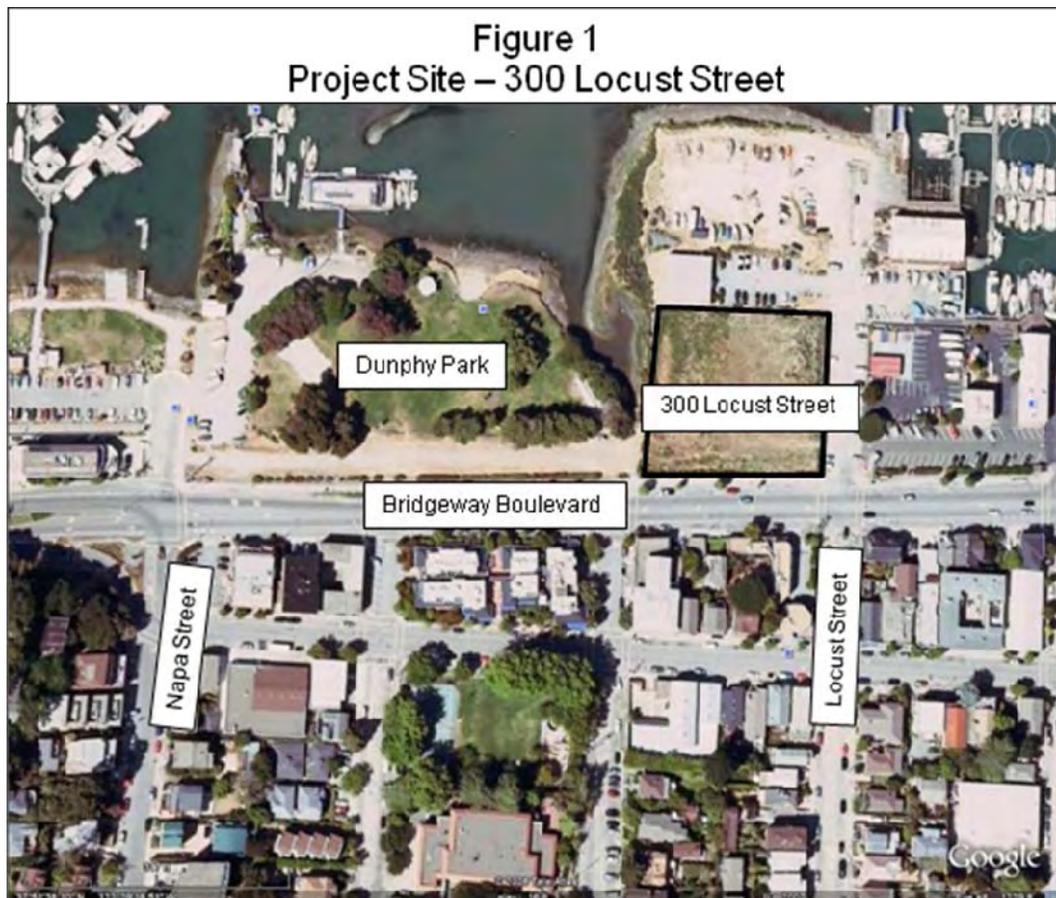
The project site, shown in **Figure 1**, is located on the northwest corner of Bridgeway Boulevard and Locust Street. The site is bounded by a small maritime business to the north, Dunphy Park to the west, Locust Street to the east and Bridgeway Boulevard to the south. The properties to the north and west are separated by an 8-foot wide asphalt pedestrian/bicycle path. The project site is generally vacant, but is used on occasion to park boats and trailers.
