HISTORICAL SUMMARY

Job: 101 Caledonia St. | 1505
RE: Historical Summary

HISTRORICAL SUMMARY:

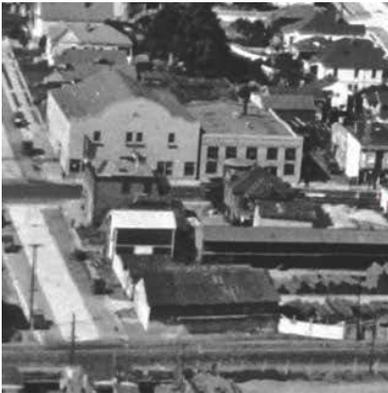
Image 1: Original Structure

The original structure was constructed as a two story, mixed use building around 1911. Within the two floors, the Marin Auto Livery Co occupied the first floor and the Tamalpais Pavilion occupied the second floor. Before the conversion to a movie theater, the building housed several different businesses and activities, a parking garage, machine shop, dances and boxing matches, skating rink, and a boat building facility. The exterior of the building was wood sided and contained windows along both Pine St. and Caledonia St. with a rounded peak parapet on Caledonia St. The main entry was located on Caledonia St. (See image 1 on following page)

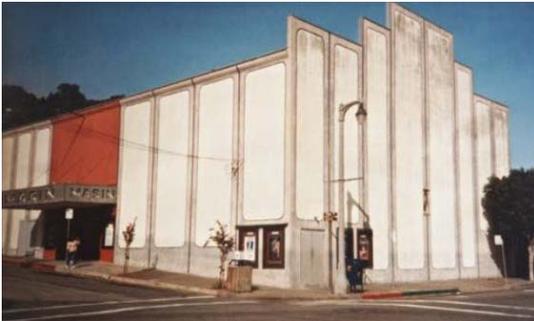
Image 2: 1942 Remodel

In 1942 the Blumenfeld Theatre Circuit purchased the building, and in turn, converted the structure into a theater. During the conversion, the entry was relocated to Pine St. and the interior contained a single large theater along with support spaces. The original rounded peak parapet on Caledonia St. was removed and replaced with a new multi-stepped parapet. Vertical lines were introduced to the exterior walls and a single marquee sign stating “Marin” was located above the new entry on Pine St. During this renovation it appears the exterior wood siding and windows on Pine and Caledonia where removed. (See image 2 on following page)

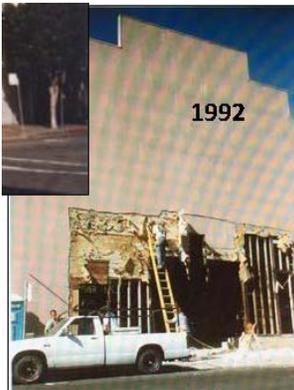
Image 3: 1992 Remodel

In 1992 another major renovation occurred. The single large theater was converted to a 3 screen multiplex theater. The extensive remodel relocated the main entry back to Caledonia St., introduced a new electric marquee sign with a new faux-window above, reconfigured and rebuilt the interior layout for both floors, existing wood columns were replaced with new structural steel columns, refinished the entire exterior stucco finish with new paint colors. A new sloped/stepped parapet was also built on the south face of the building. All detailing along Pine St. was removed and replaced with a uniform stucco wall. (See image 3 and 4 on following page)

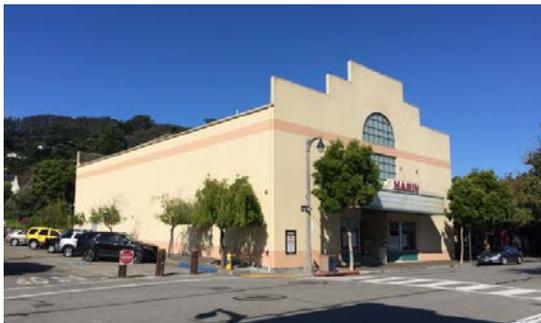
Image 4: Structure as of 2016
