## CITY OF SAUSALITO

TO: Historic Landmarks Board  
FROM: Calvin Chan, Associate Planner  
DATE: October 6, 2016  
SUBJECT: Tanglewood / Levin Residence | 168 Harrison Avenue

**168 Harrison St., Sausalito  
Historical Landmark Amendment**

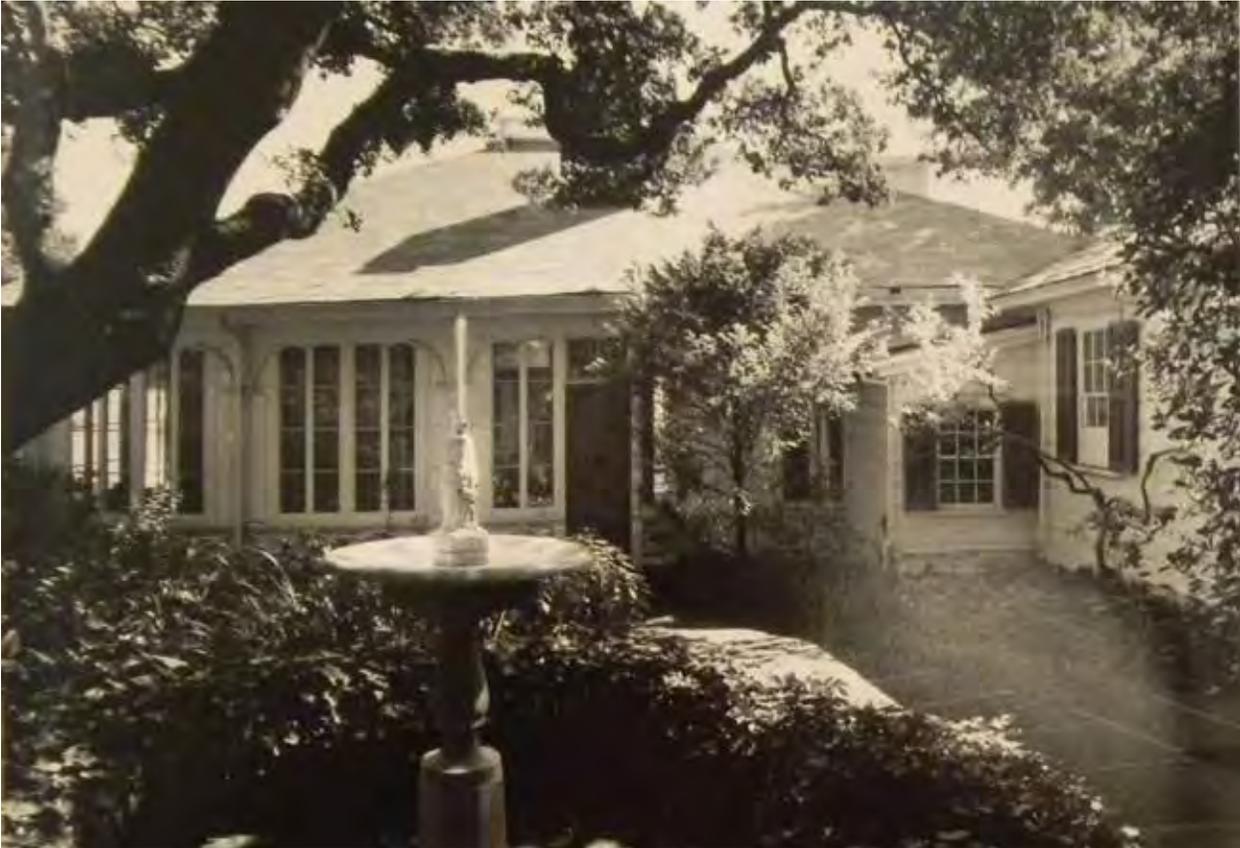
Figs.3-4 - 168 HARRISON ST. – 1990 EXTERIOR PHOTOS OF HOUSE

WEST (FRONT)

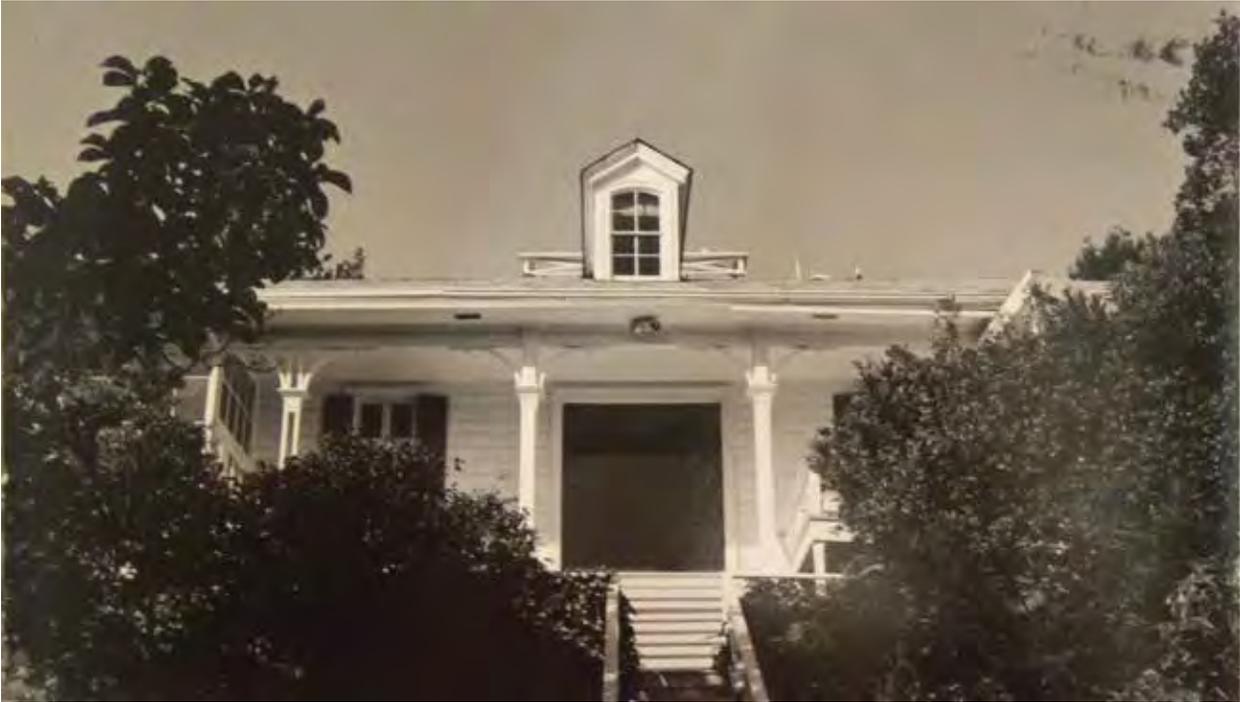
EAST (REAR)

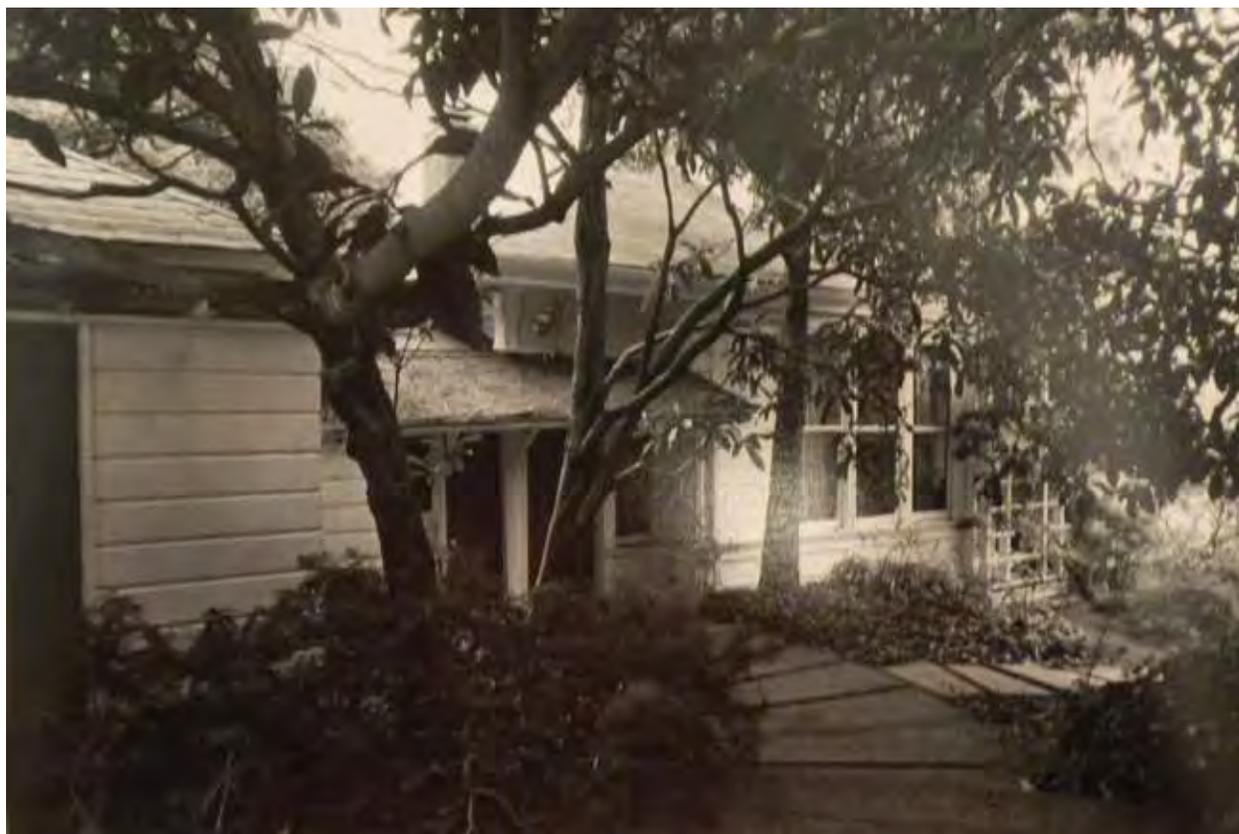
Figs.5-6 - 168 HARRISON ST. – 1990 PHOTOS

SOUTH SIDE

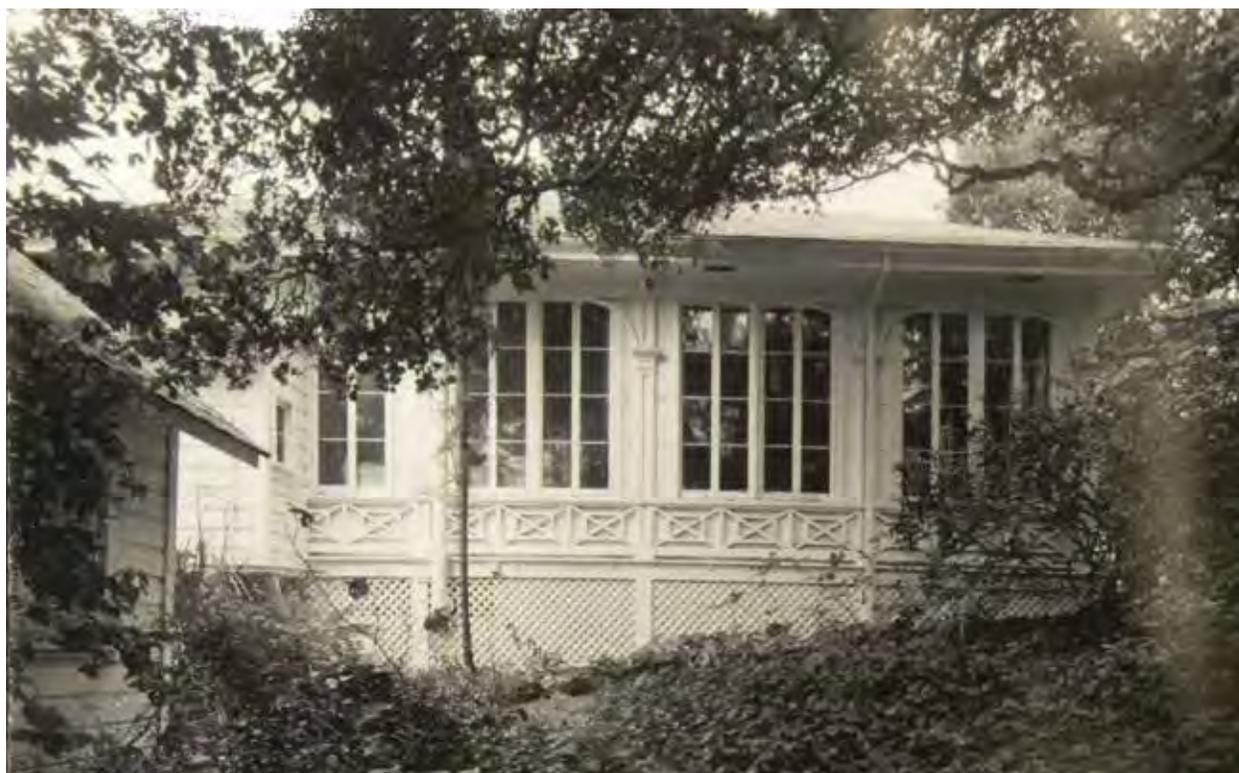
NORTH SIDE

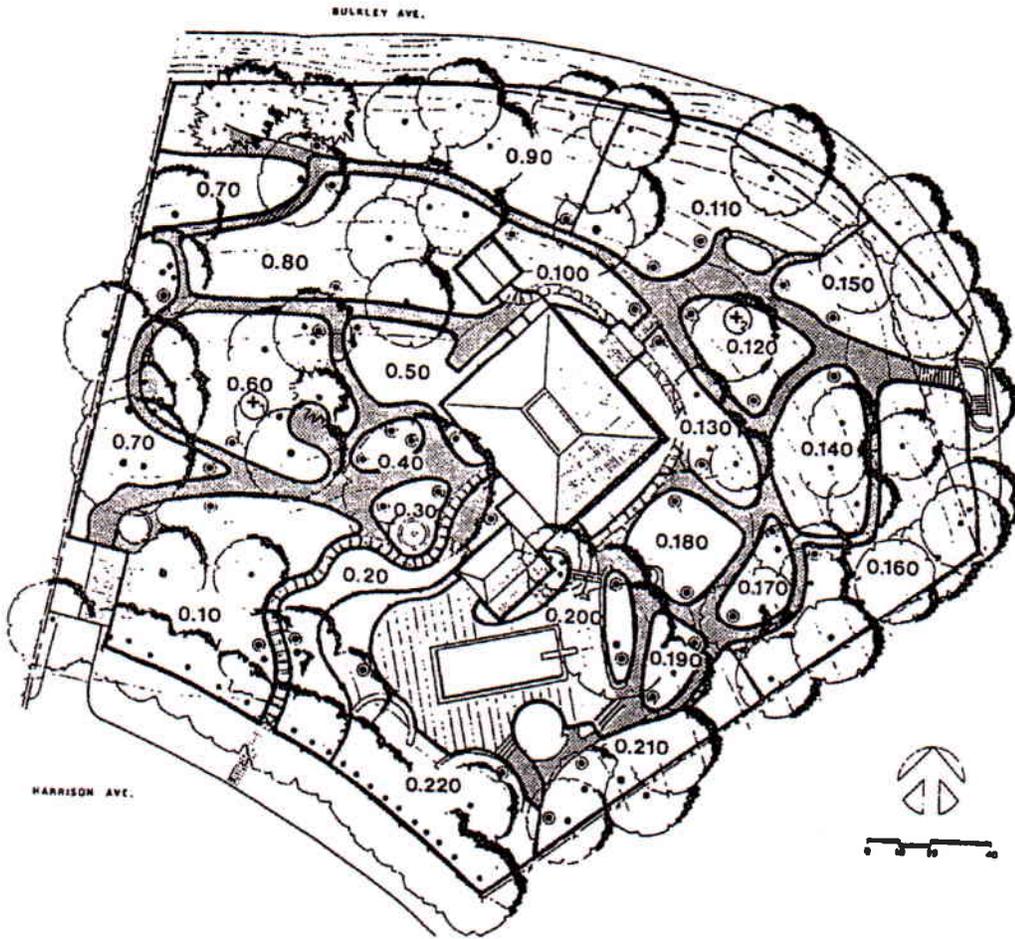
**Fig. 4**

**PLANTING BED LOCATIONS**

0.10-  
0.220 Bed Numbers

For ease in identification, the garden has been divided into three sections in response to visual differentiations within the site. (Fig. 4) The three sections are denoted here as, the Oak Glen, (characterized by numerous, massive oaks west of the house), the Magnolia Circ, (reflecting the presence of several specimen magnolias northwest of the house), and the Terrace, (complete with swimming pool and patio area southeast of the house). The overall visual impact of each of the sections will be discussed along with a critical evaluation of the various plant materials. The overall physical conditions present on the site are discussed followed by specific comments and recommendations for each of the sections. (It is important to note here that these recommendations are made only for the explicit purpose of maintenance; for improving the physical condition of the individual plants. This section was written as merely a guide for maintaining the existing layout and features of the site and does not preclude or reduce the immediate need for a master plan for the Allen Garden.)

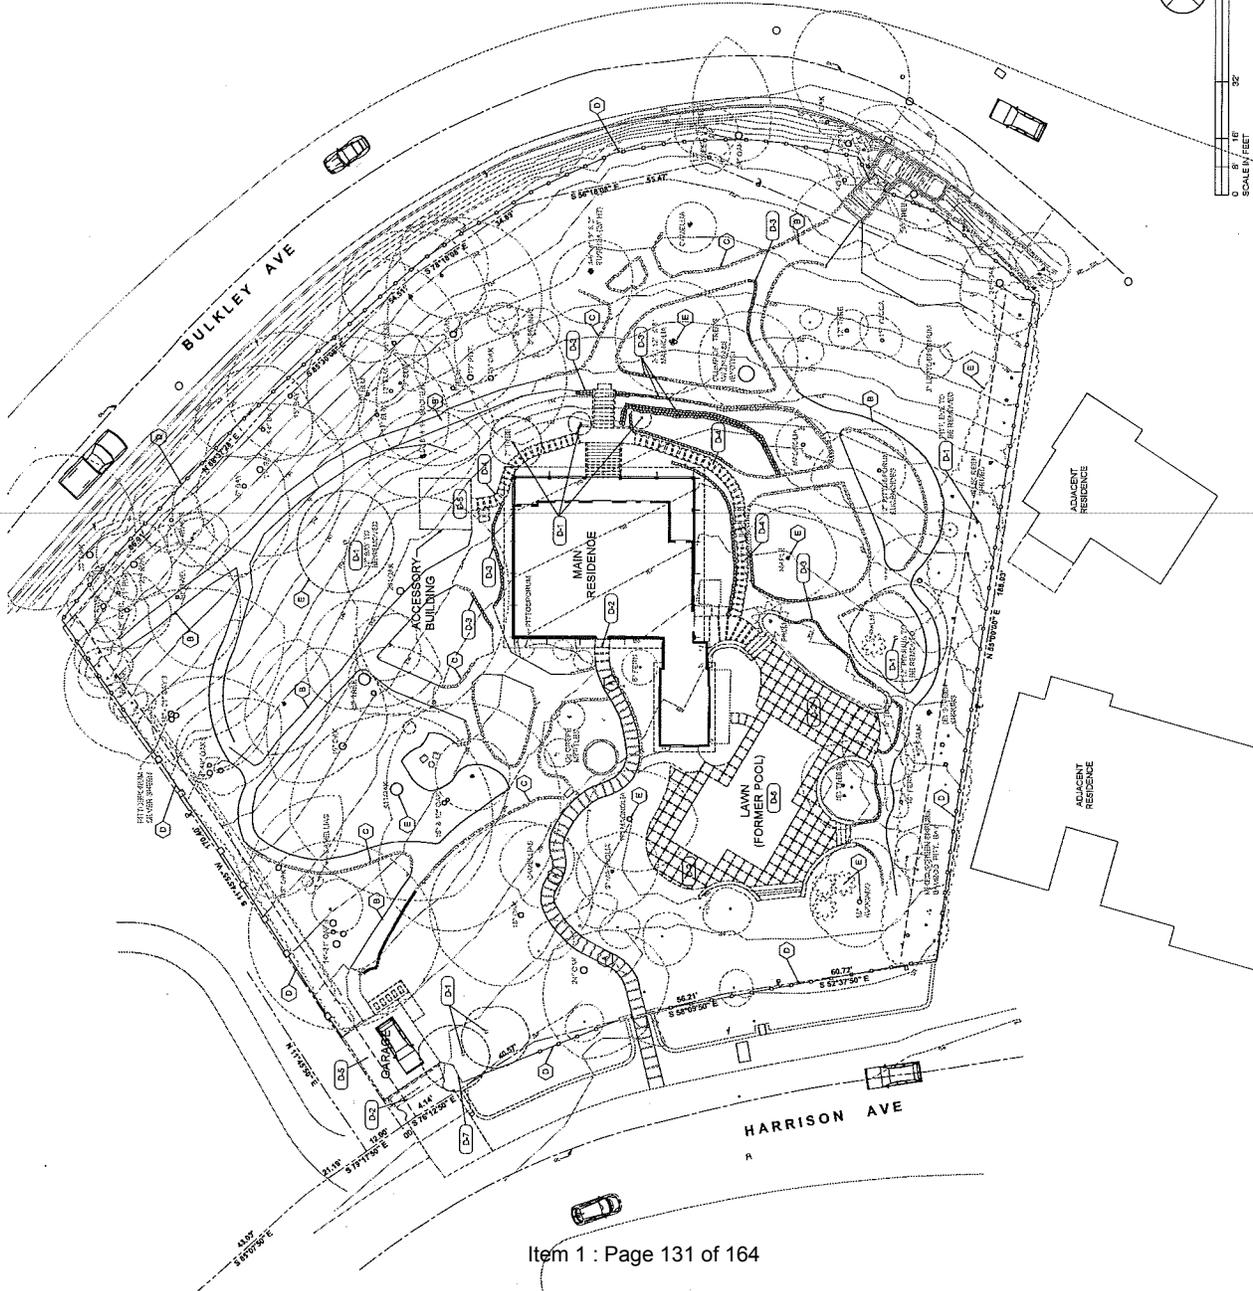
**EXISTING CONDITIONS SITE PLAN**

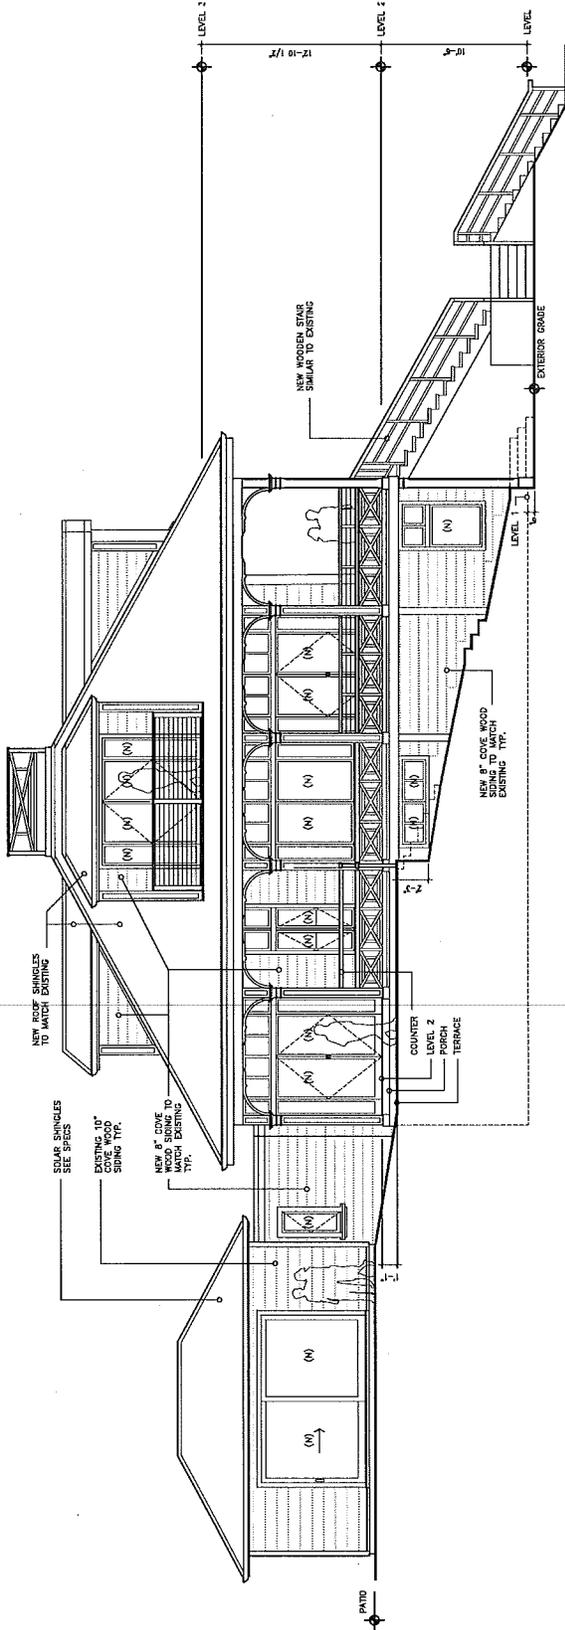
**1 PROPOSED SOUTH ELEVATION**  
SCALE 1/4" = 1'-0"

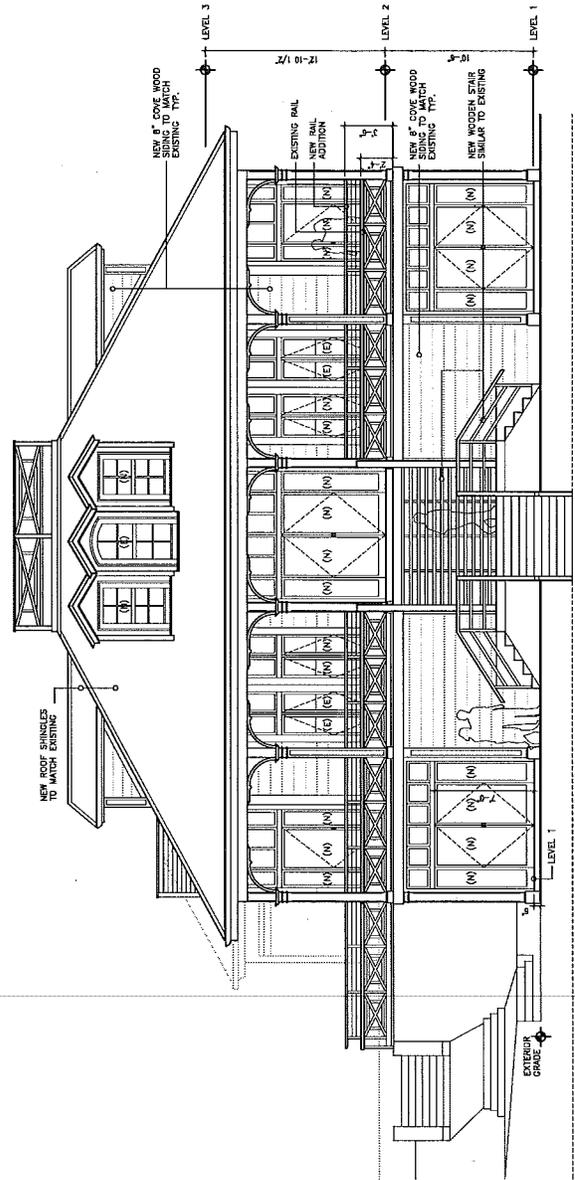
**2 PROPOSED EAST ELEVATION**  
SCALE 1/4" = 1'-0"

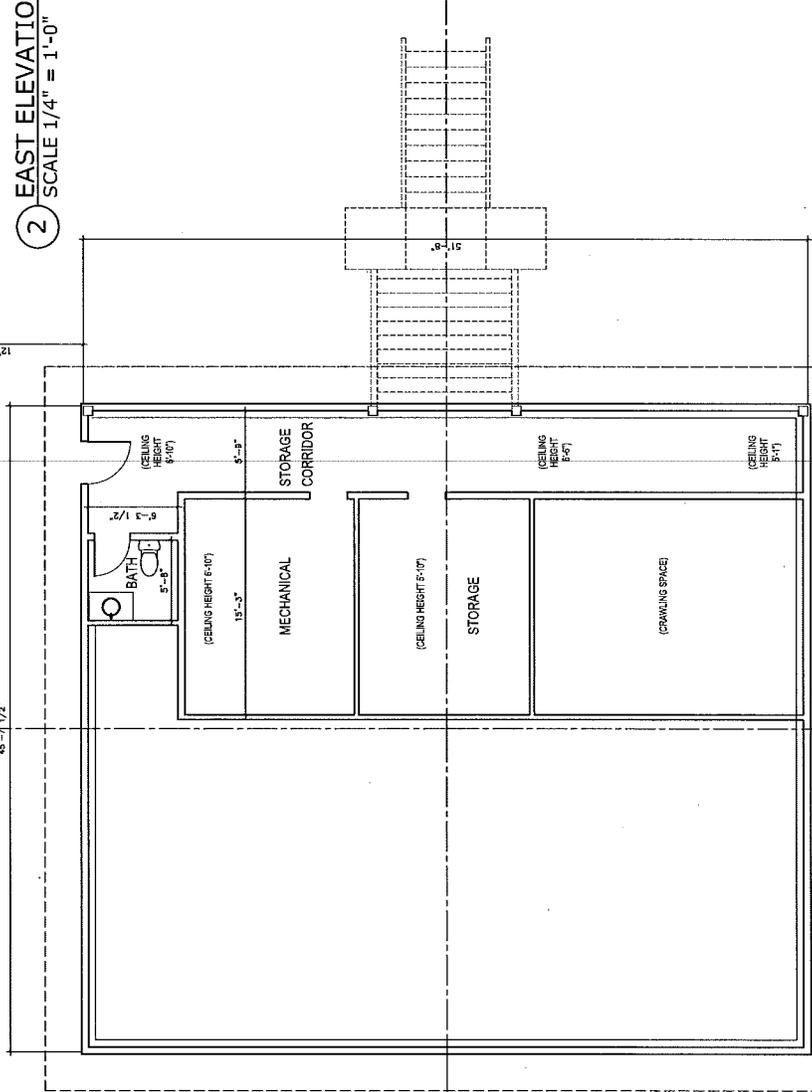
**1 EXISTING BASEMENT PLAN**  
SCALE 1/4" = 1'-0"

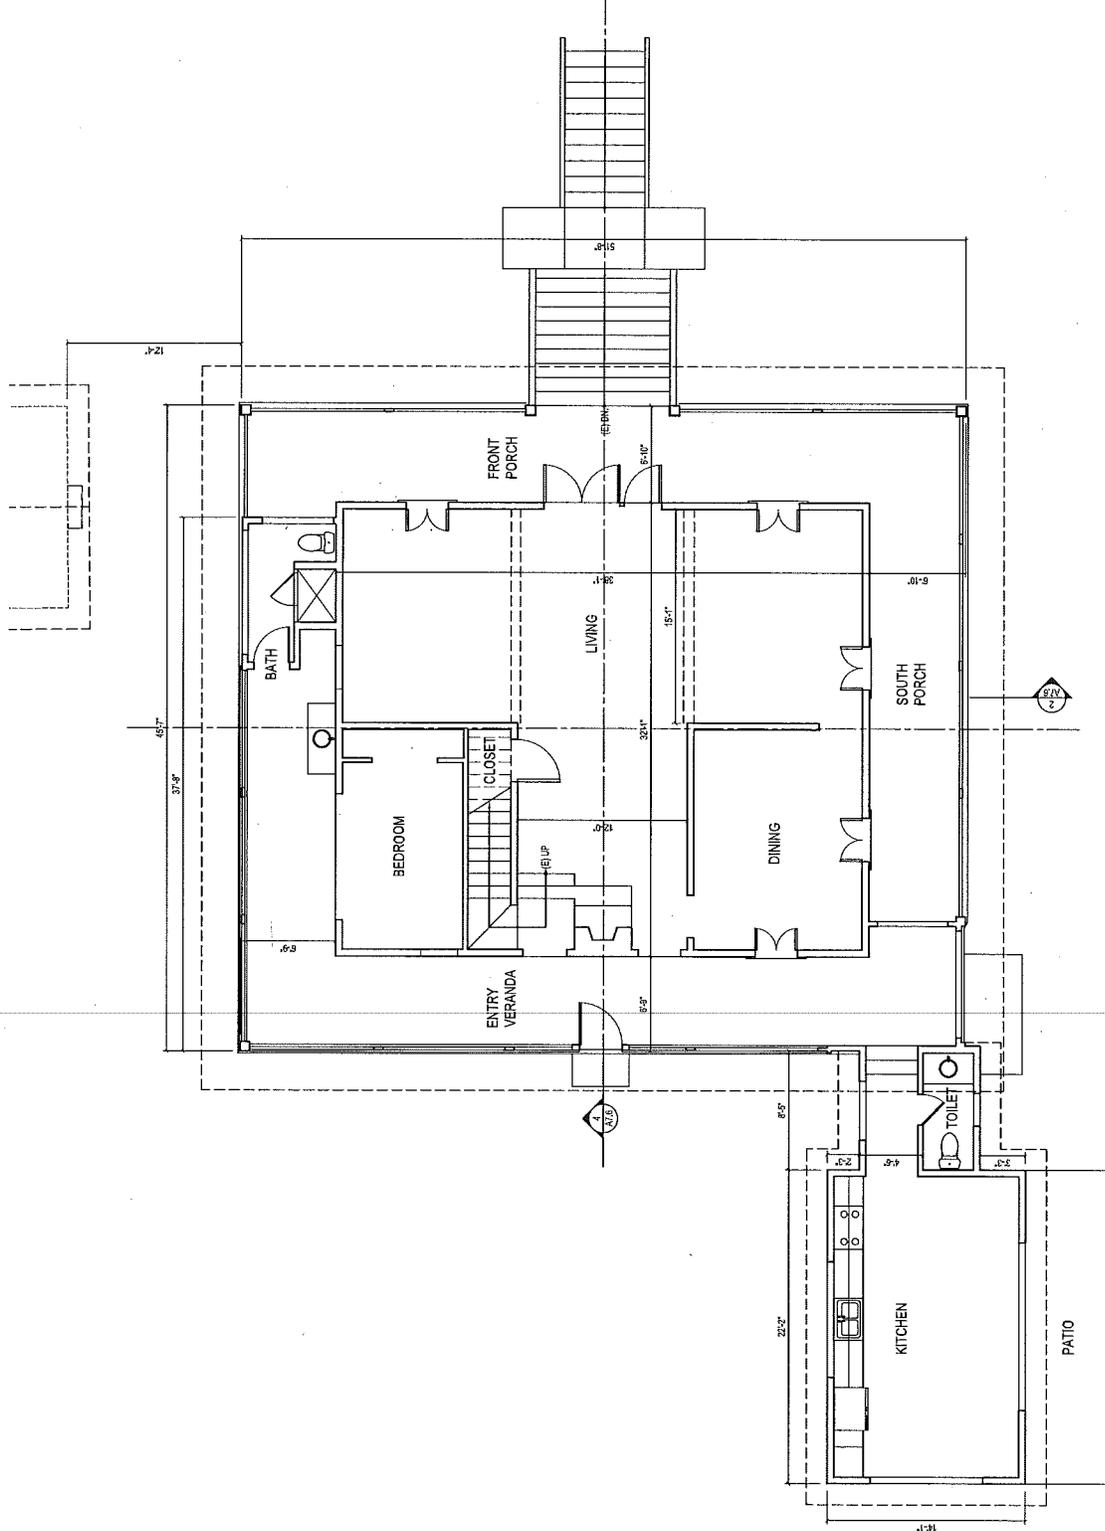
**1** EXISTING HOUSE PLAN - LEVEL 2  
SCALE 1/4" = 1'-0"

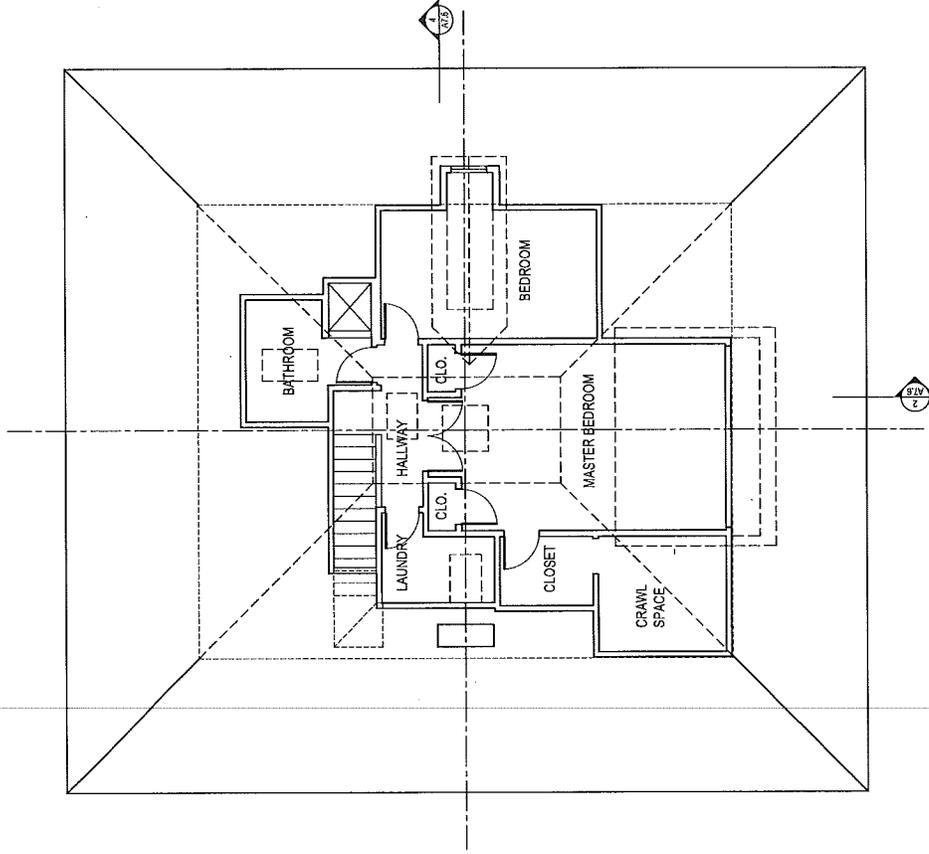
**1** EXISTING HOUSE PLAN - LEVEL 3  
SCALE 1/4" = 1'-0"

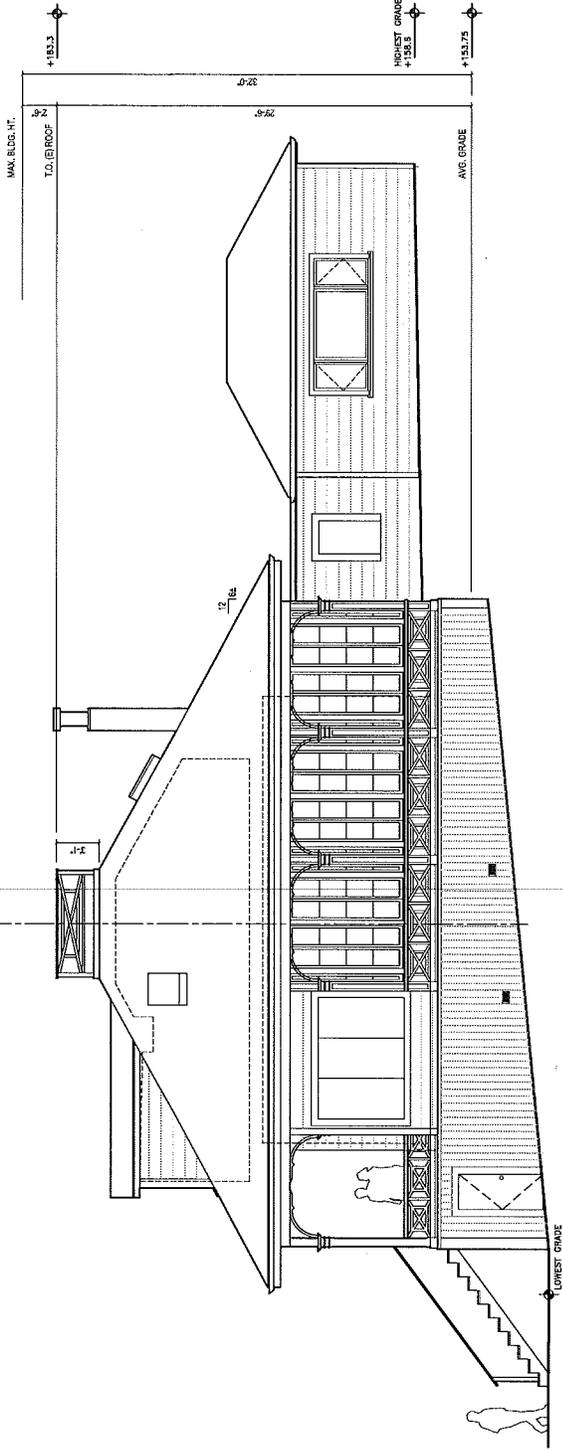
1 EXISTING NORTH ELEVATION  
SCALE 1/4" = 1'-0"

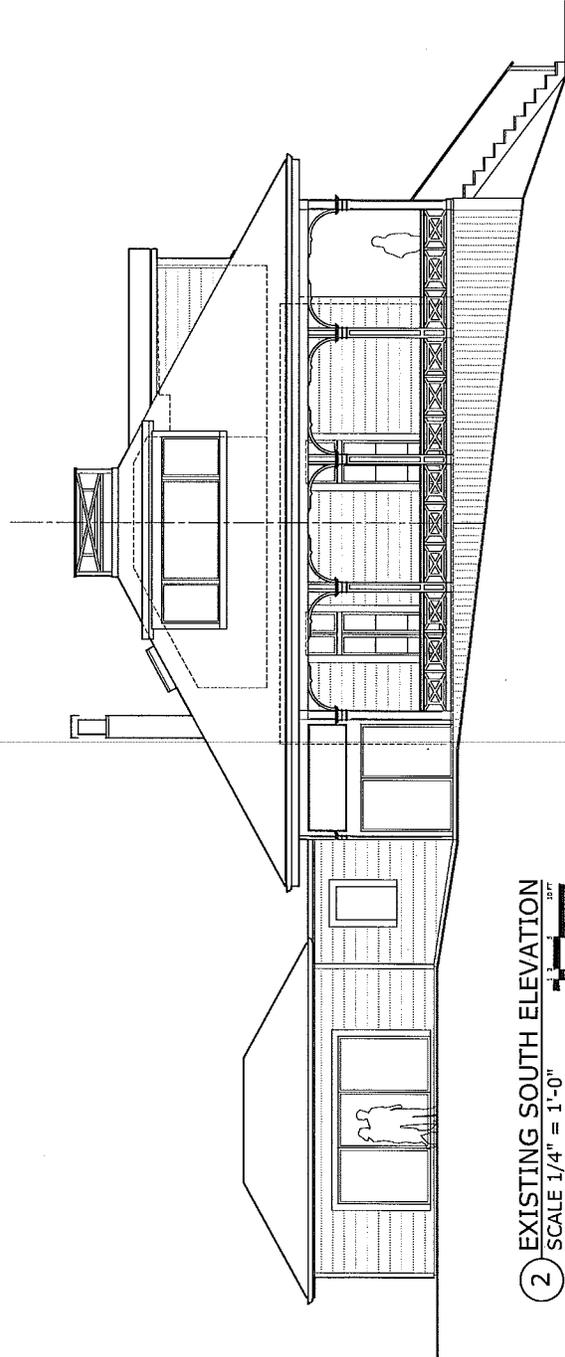
2 EXISTING SOUTH ELEVATION  
SCALE 1/4" = 1'-0"

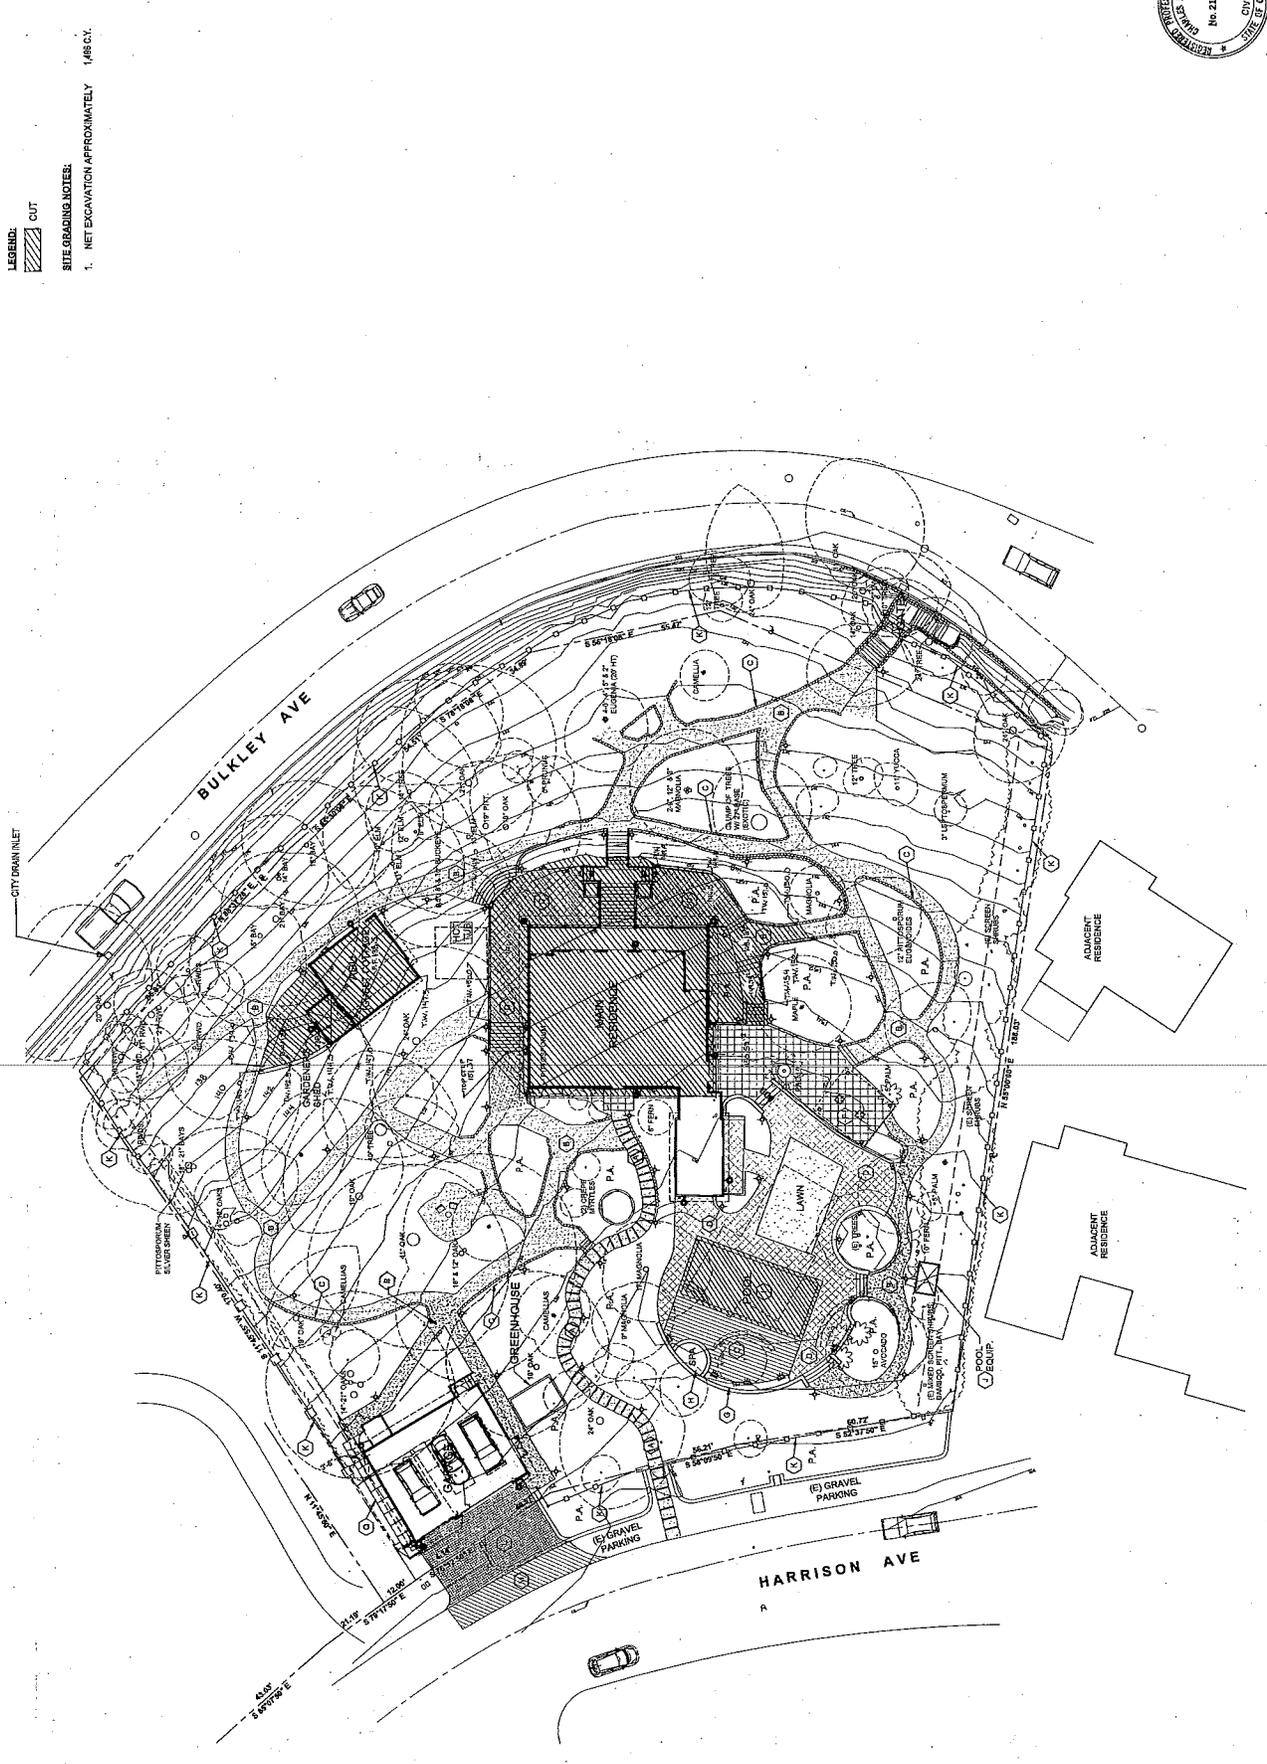
**LEGEND:**  
 [Hatched Box] CUT

**SITE GRADING NOTES:**  
 1. NET EXCAVATION APPROXIMATELY 148 C.Y.
