Pre-Demolition Asbestos and Hazardous Materials Survey

Former Sausalito Police Station (29 Caledonia Street) and Sausalito Fire Station #1 (300 Johnson Street), Sausalito, CA.

1 December 2005

Project Number: 05421

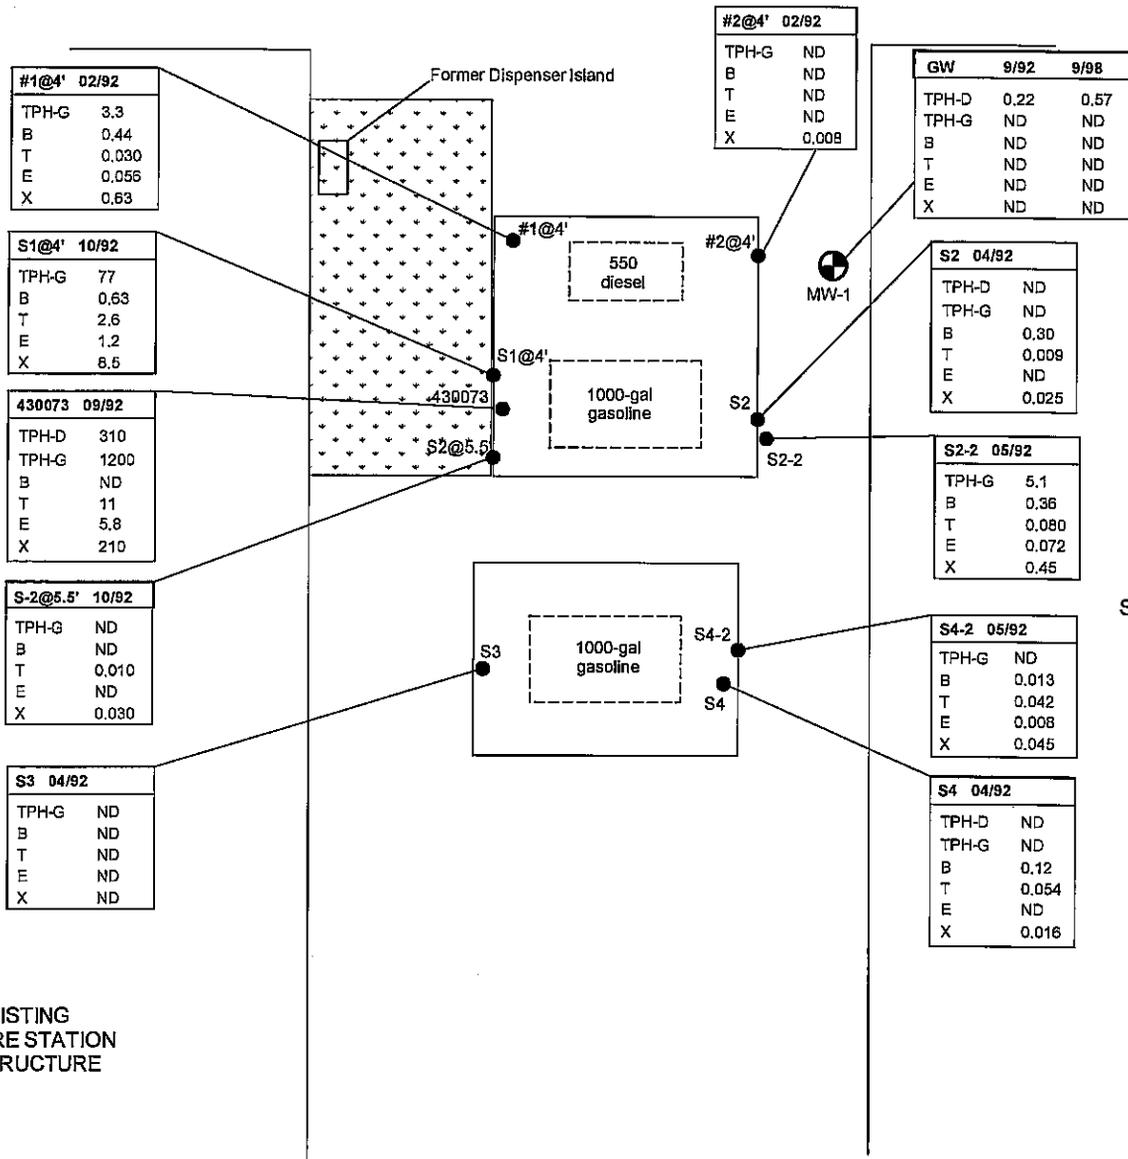
- Former Monitoring Well Location (Certified Environmental Consultants)
- Previous Soil Sample Location (Certified Environmental Consultants)
- Former UST Location (Removed in 10/91)
- Extent of Former UST Excavation
- TPH-D Total Petroleum Hydrocarbons as Diesel - mg/kg (ppm)
(Performed with silica gel clean up)
- TPH-G Total Petroleum Hydrocarbons as Gasoline - mg/kg (ppm)
- B Benzene - mg/kg (ppm)
- T Toluene - mg/kg (ppm)
- X Total Xylenes - mg/kg (ppm)
- E Ethylbenzene - mg/kg (ppm)
- Approximate Area of Potential Residue Diesel/Gasoline Range Hydrocarbon Soil Contamination
