# STAFF REPORT

## SAUSALITO PLANNING COMMISSION AND HISTORIC LANDMARKS BOARD

**Project** Casa Madrona Renovation / 801 Bridgeway  
Design Review Permit and Nonconformity Permit  
DR/NC 10-377

**Meeting Date** October 26, 2011

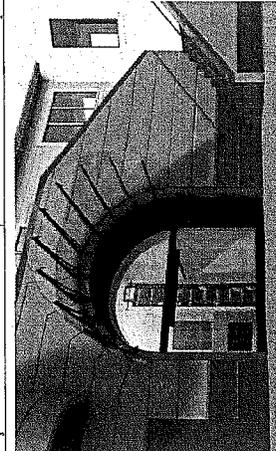
4 3D PERSPECTIVE VIEW  
NO SCALE

**AWNING DESIGN NOTES:**  
 1. GLAZE TO LEFT (SOUTH) AND AWK. PRESERVE VISUAL RECORDS. RELATE TO OTHER FLOORINGS.  
 2. SHIELD PAINTING TO MATCH WITH CONCRETE.  
 3. SHIELD PAINTING TO MATCH WITH CONCRETE.  
 4. OPEN FACED TO RELATE TO AWNING ON 777 PROPERTY.  
 5. AWNING TO REMAIN 100% WITHIN 801 BRIDGEWAY PROPERTY.

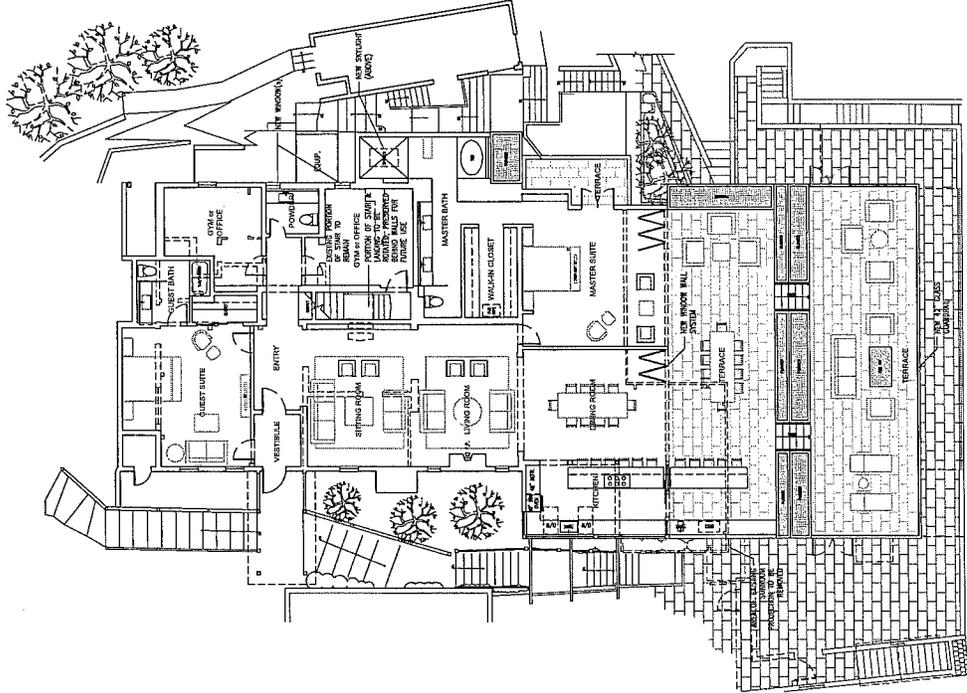
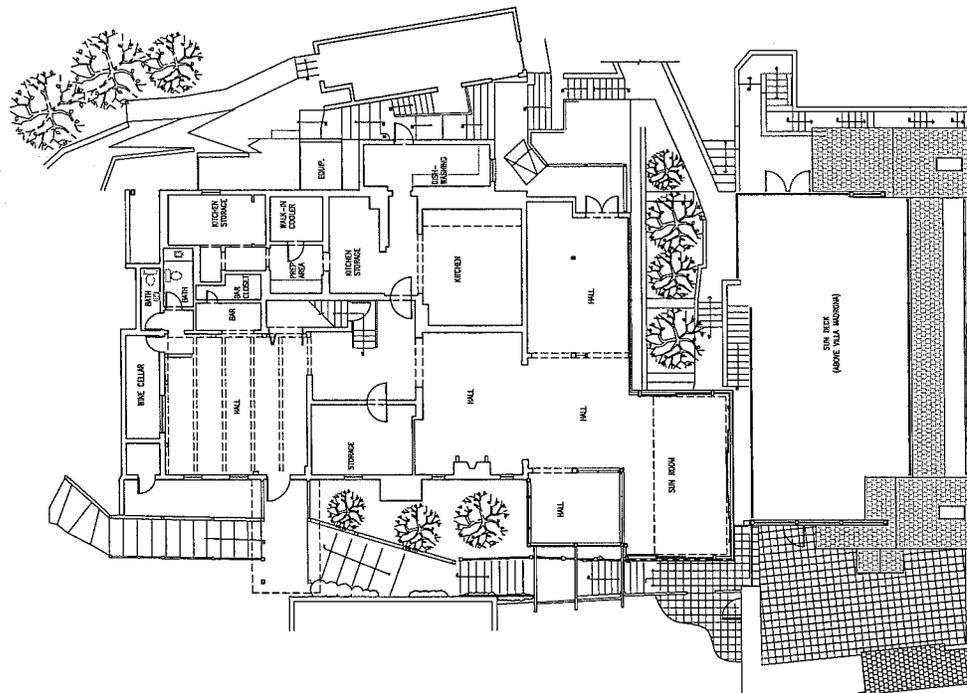
1. EXISTING CONFIGURED AS COMMERCIAL KITCHEN, STORAGE, WINE CELLAR, AND HALLS. THERE ARE (2) EXISTING BATHROOMS.
2. PROPOSED THE PROPOSED USE IS FOR (2) GUEST ROOMS, ONE AS A PRESIDENTIAL SUITE WITH KITCHEN/DINING/LIVING ROOM, SITTING ROOM, OFFICE, CLO, MASTER SUITE, BATH, AND WALK-IN CLOSET. THE OTHER GUEST ROOM MAY BE CONNECTED TO THE PRESIDENTIAL SUITE OR LET SEPARATELY. BOTH ARE INTENDED FOR SHORT TERM HOTEL GUESTS.

**2 PROPOSED FIRST FLOOR PLAN**  
SCALE: 1/8" = 1'-0"

**1 EXISTING FIRST FLOOR PLAN**  
SCALE: 1/8" = 1'-0"

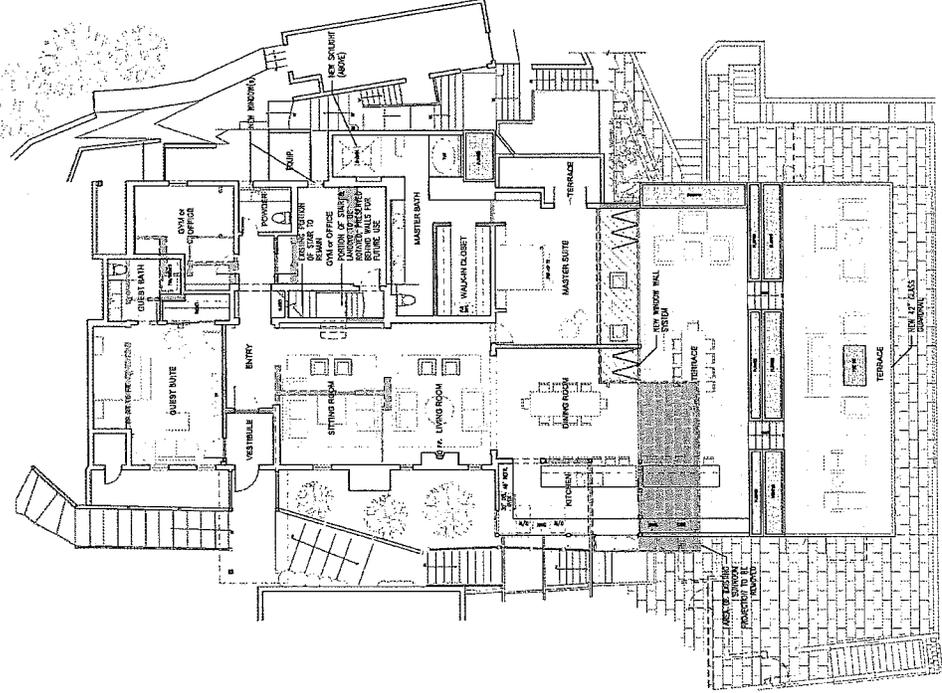
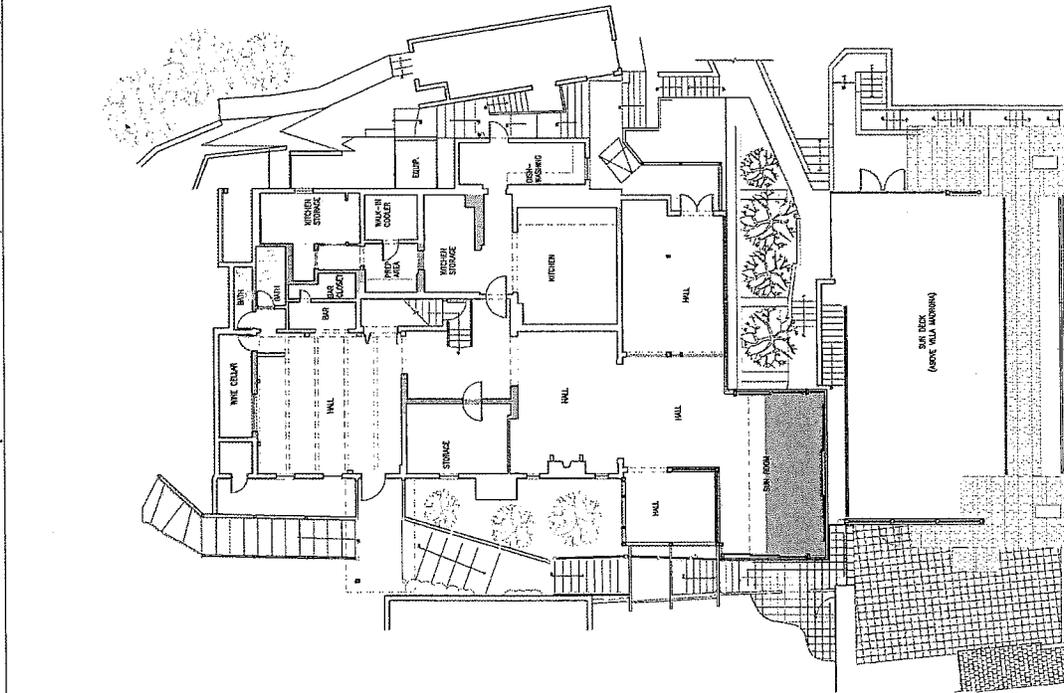
2 PROPOSED FIRST FLOOR PLAN  
SCALE: 1/8" = 1'-0"

1 EXISTING FIRST FLOOR PLAN  
SCALE: 1/8" = 1'-0"
